STATISTICAL BASED AN INVESTIGATION OF FAILURE OF POWER TRANSFORMERS AND REACTORS

Shubham Vyas*, Vijay Yadav^

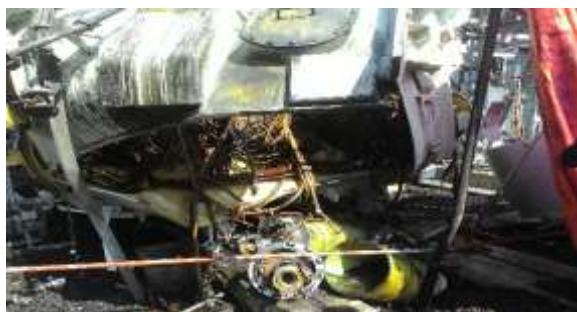
During the experiments by Electricity de lab in France in the year 2002 and the second by Brazilian high voltage laboratory CEPTEL, in 2004 on large transformers, the Buchholz always failed to detect any gas and oil movement in respective time. During a transformer short-circuit, the electrical arc vaporizes oil and creates a dynamic pressure which travels at the speed of 1,200 meters per second (4,000 feet per second). Pressure build-up

inside the tank which eventually leads to rupture is caused by the high amount of energy released by the arc. Were,

Then, the pressure becomes equal throughout the entire transformer tank within 50 to 100 milliseconds after the electrical arc and causes the transformer tank to rupture [4].

Fig 1- Catastrophic view of transformer after burst and fire.

- 1) During engineering following points must be considered as Minimal joints in windings, minimal nut-bolts fixing arrangements.
- 2) We recommend using at least 3 PRD, 1 in each phase of 5 limbed 3 phase transforms. To reduce main tank rapture.

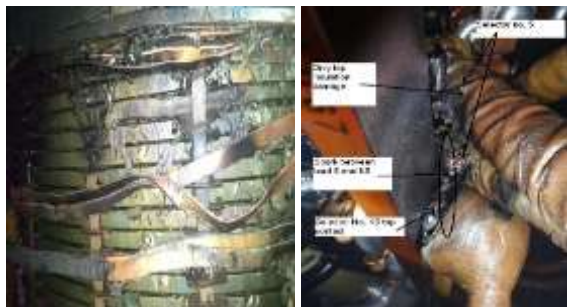
The function of the windings is to carry current. Faults that occur in the winding are due to these stresses [5]. These windings withstand dielectric, thermal and mechanical stress during this process, which caused deformation of windings. Fig 2 explains the deformation. Dielectric faults occur in the winding due to inter turn insulation breakdown. Insulation breakdown generally occur due over loading w.r.t rated design. The breakdown of the insulation results flashover between winding turns and cause short circuit.

Insulations are hygroscopic in nature. Based on the physical and chemical properties of both cellulose materials and oil they react with increase of temperature, Hot spot, chattering, loose connection is the major source of degradation. Below referred fig showing damage of insulation & winding deformation.

Fig 2 & 3 – Winding deformation & insulation failure.
