INTERNATIONAL JOURNAL OF CREATIVE RESEARCH THOUGHTS (IJCRT)

An International Open Access, Peer-reviewed, Refereed Journal

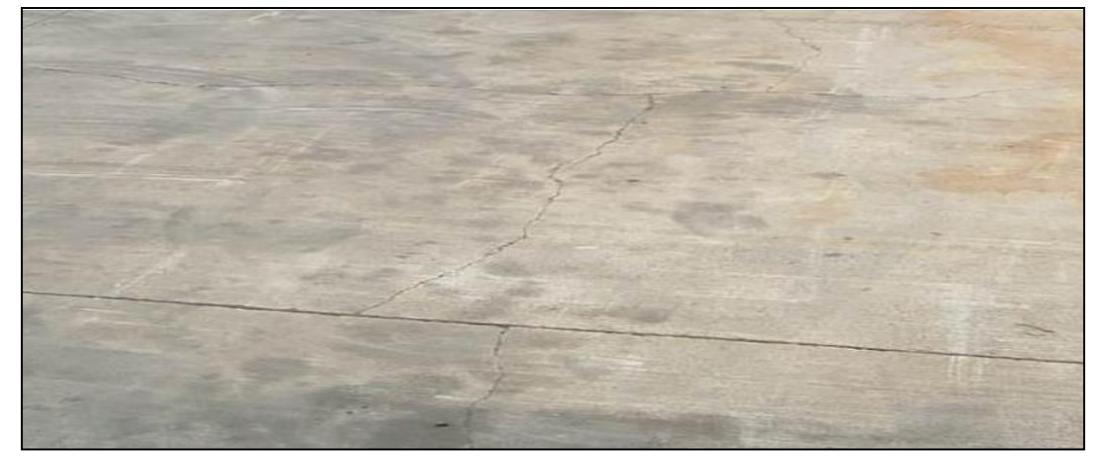
Fig-1: Concrete random cracking. Cracks run parallel to and perpendicular to saw cut joints.

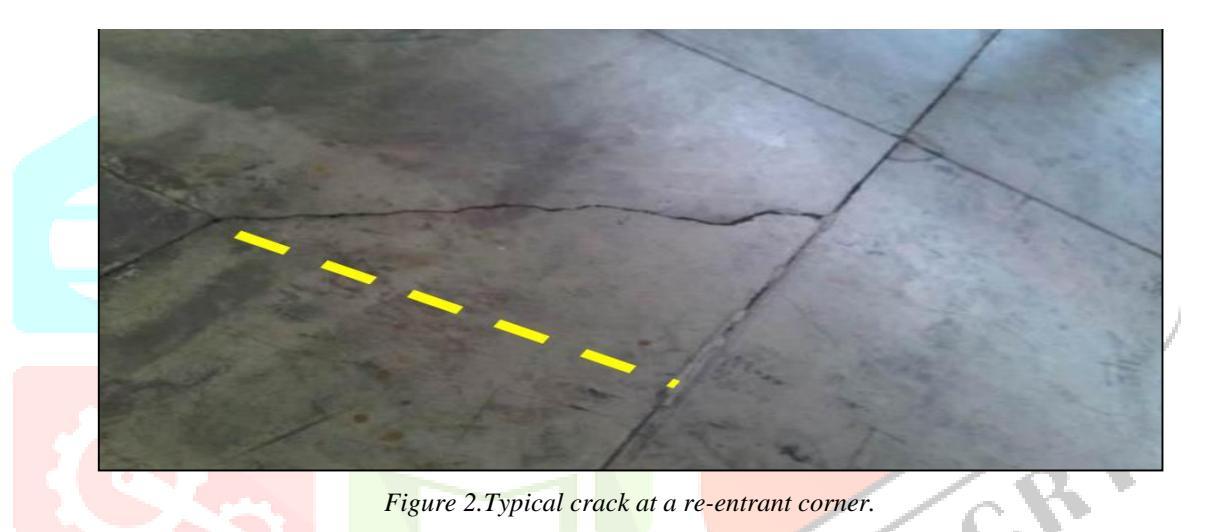
The crack in Fig.2 was caused by poor floor design and did occur at a re-entrant corner. The concrete shrank in two directions, increasing the stresses along the diagonal crack path. To avoid such issues, a saw cut along the dotted yellow line should have been made, or diagonal reinforcement should also have been placed across this section. This crack may not impair the floor's performance, but it is unsightly and was included on the claim against by the consultant and design engineers.

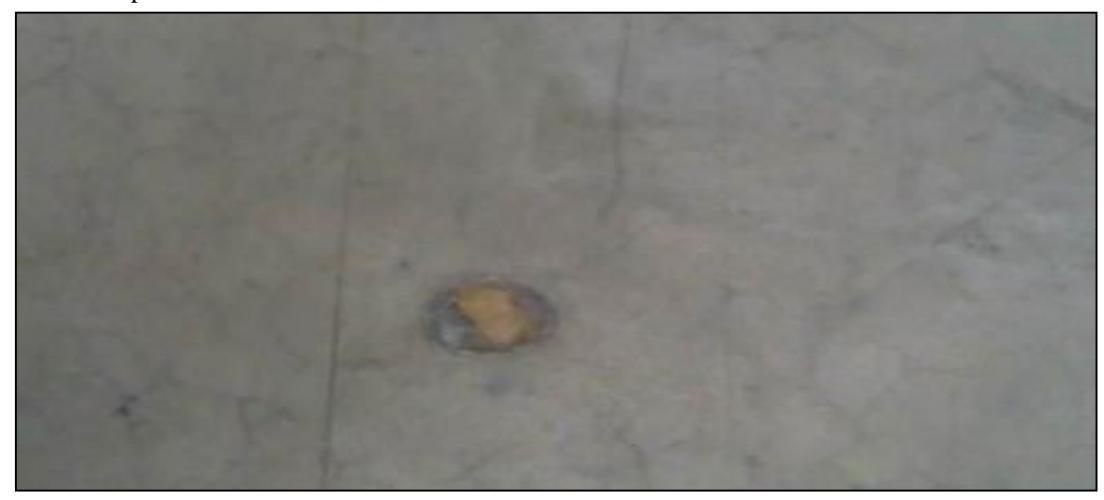
Figure 3: Concrete floor pop-out due to impurities

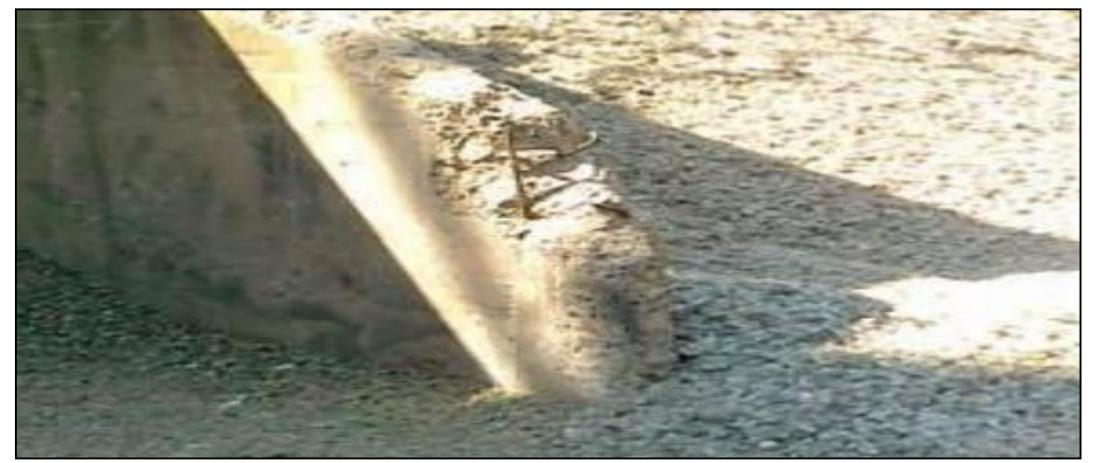
Figure 4: Exposed rebar due to the abrasion

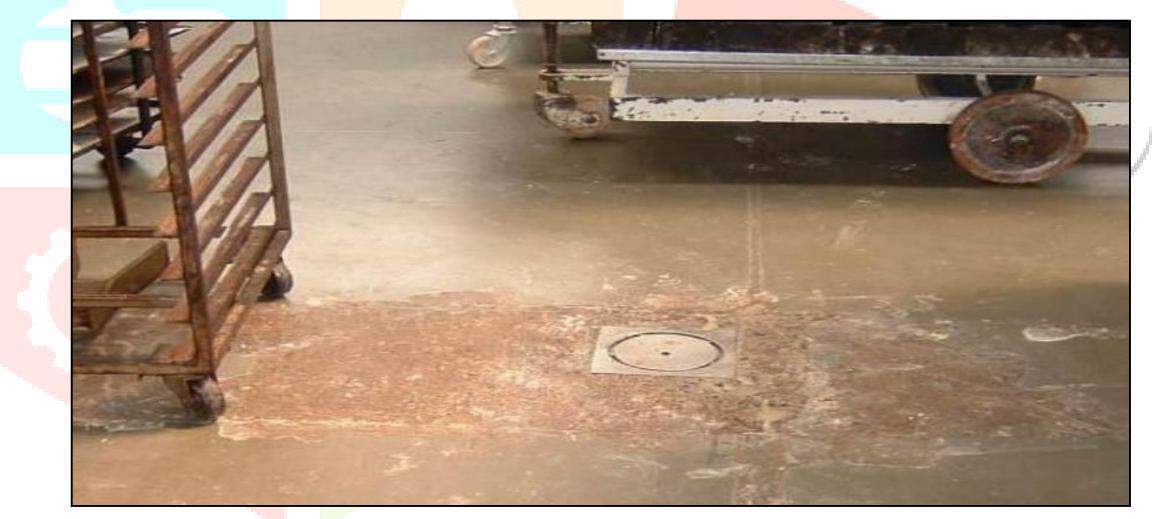
Figure 5: An acid attack on the flooring.

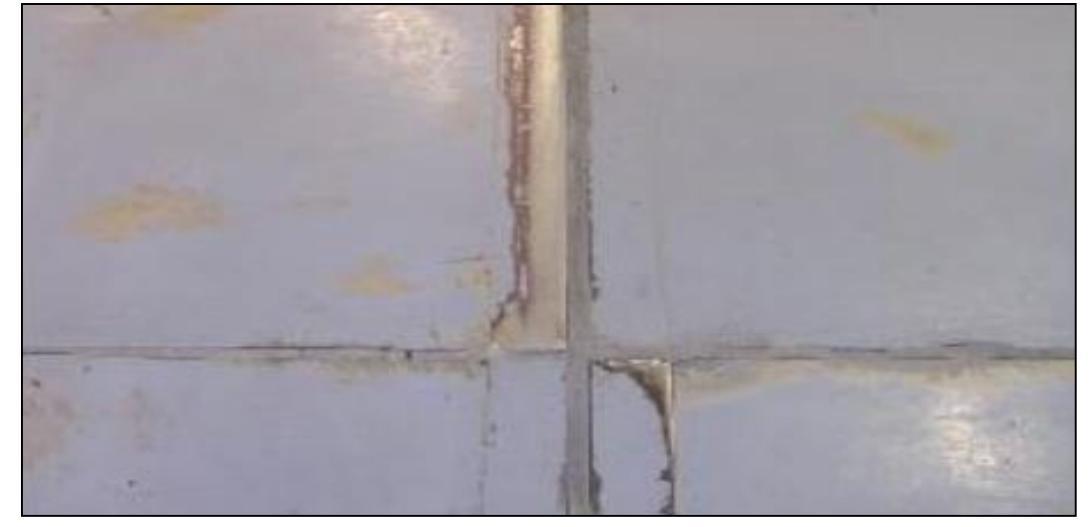
Figure 6: Damage caused, collapsed, and curled construction joints.

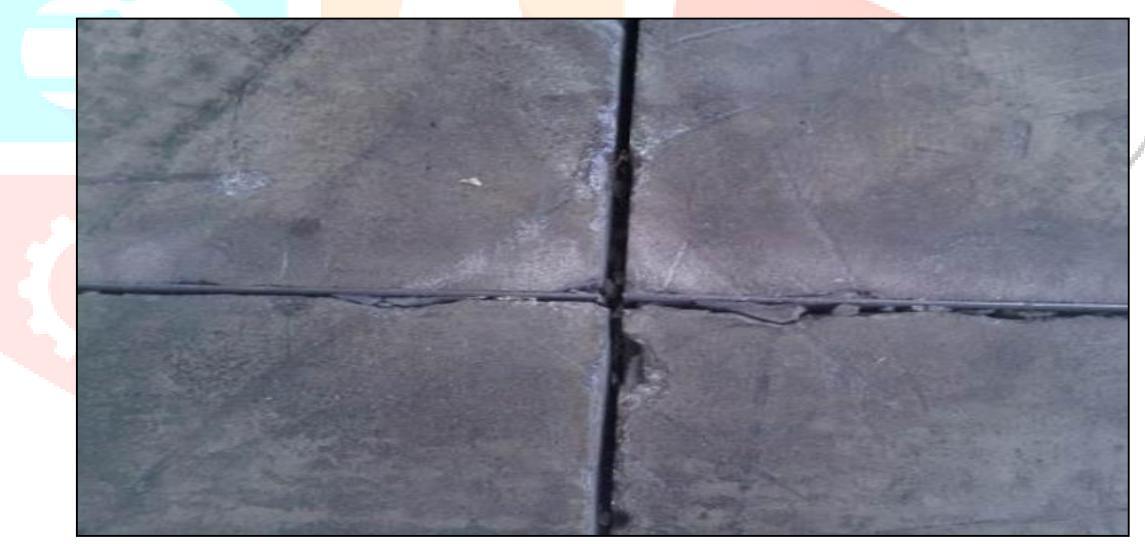
Figure 7 Photograph of a sawcut joint that has been improperly sealed and damaged

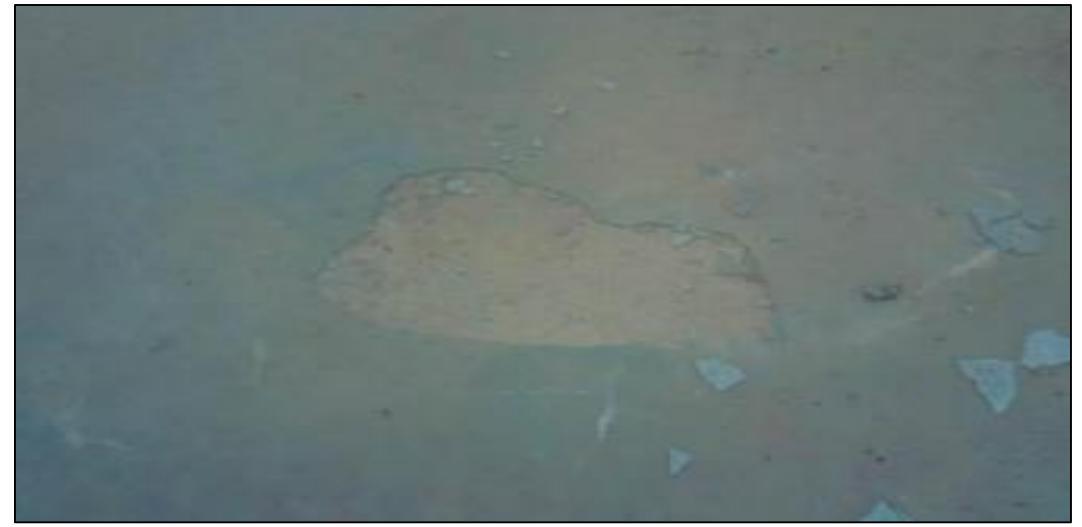
Figure 8: Delamination of a floor

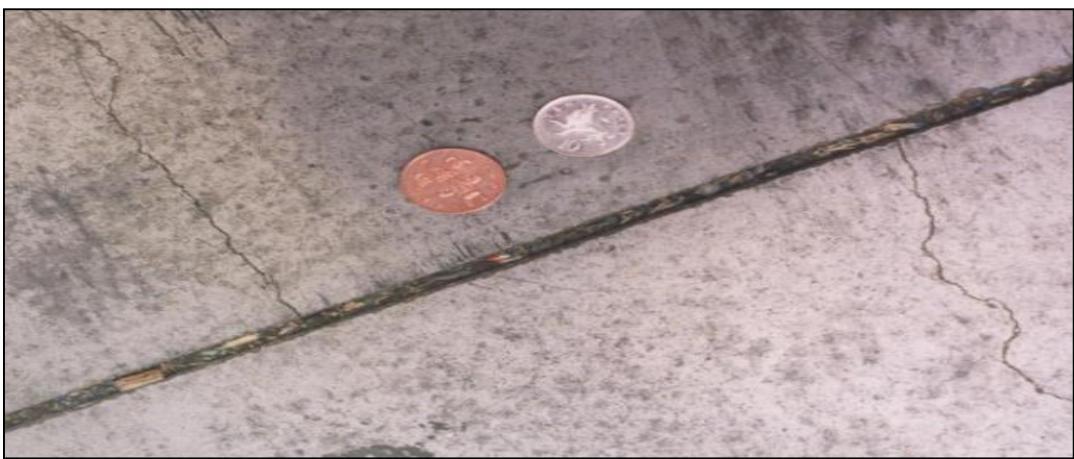
Figure 10: Concrete floor thermal contraction cracking
