# CONSERVATION OF AMARAT ALI FAKHRO'S STOREHOUSE, MUHARRAQ, BAHRAIN – A CASE STUDY

Abstract: The kingdom of Bahrain is an archipelago of 33 Islands located in the Arabian Gulf. The island covers 770 square kilometres of land which is connected to the kingdom of Saudi Arabia to the west through the king Fahd Causeway. In Arabic the word Bahrain is a dual form of bahar; it means sea. The name is derived from the topography of the island, as it is surrounded by two kinds of water, sweetwater springs and salty water. This island has started to build its architectural identity in the last 200 years. This paper focuses on the conservation, renovation and rehabilitation of the Amarat Ali Fakhro-I storehouse located in Muharraq, Bahrain. This storehouse devours distinguished architectural elements which are constructed using locally available traditional building materials. This paper throws a light on the structural conservation techniques used on the conservation and renovation of Amarat's storehouse.

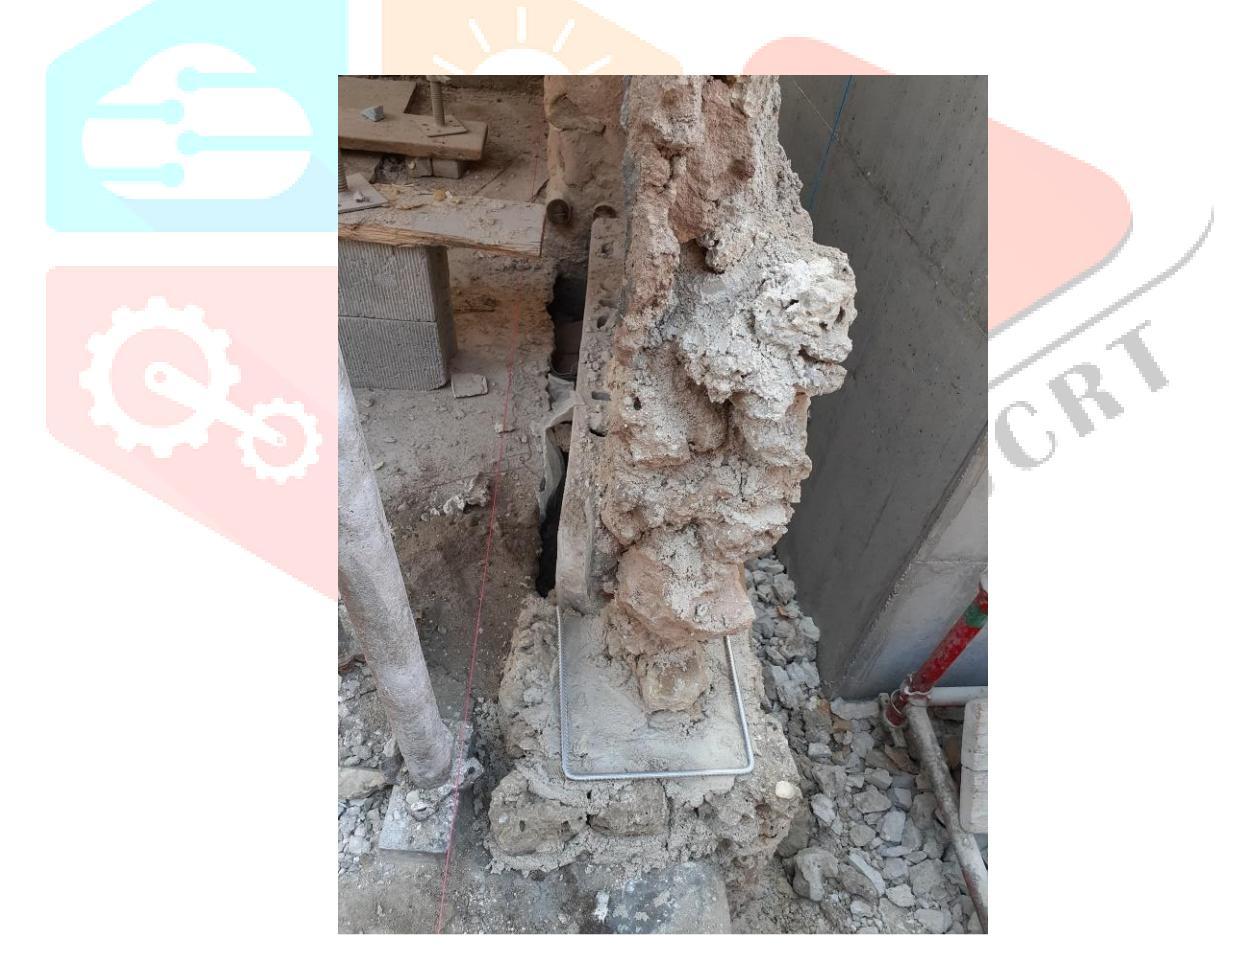
The storehouse was occupied by foreign, low income labourers who neglected in dealing with the house's physical features or in adding extra structures when there was a need for extra spaces. These additional structures were added using modern materials-cement and blocks, hence, they were not in harmony with the architecture, and also without any respect for the authenticity and values of the building. In addition to the fact that the storehouse didn't face any level of maintenance for a number of years. The condition of the wooden doors, windows, stained glasses were not maintained properly nor renovated ever. Due to the capillary actions of salt water, the plastering of walls and several parts of the structure was damaged (Fig.1). The ceiling and danchel were filled with dust and dirt which gave an ugly look on the interiors. The floors and walls had cracks in several areas. There were deep cracks in the joints between the traditional walls and the added cement walls.

Fig.1. Damaged wall before conservation

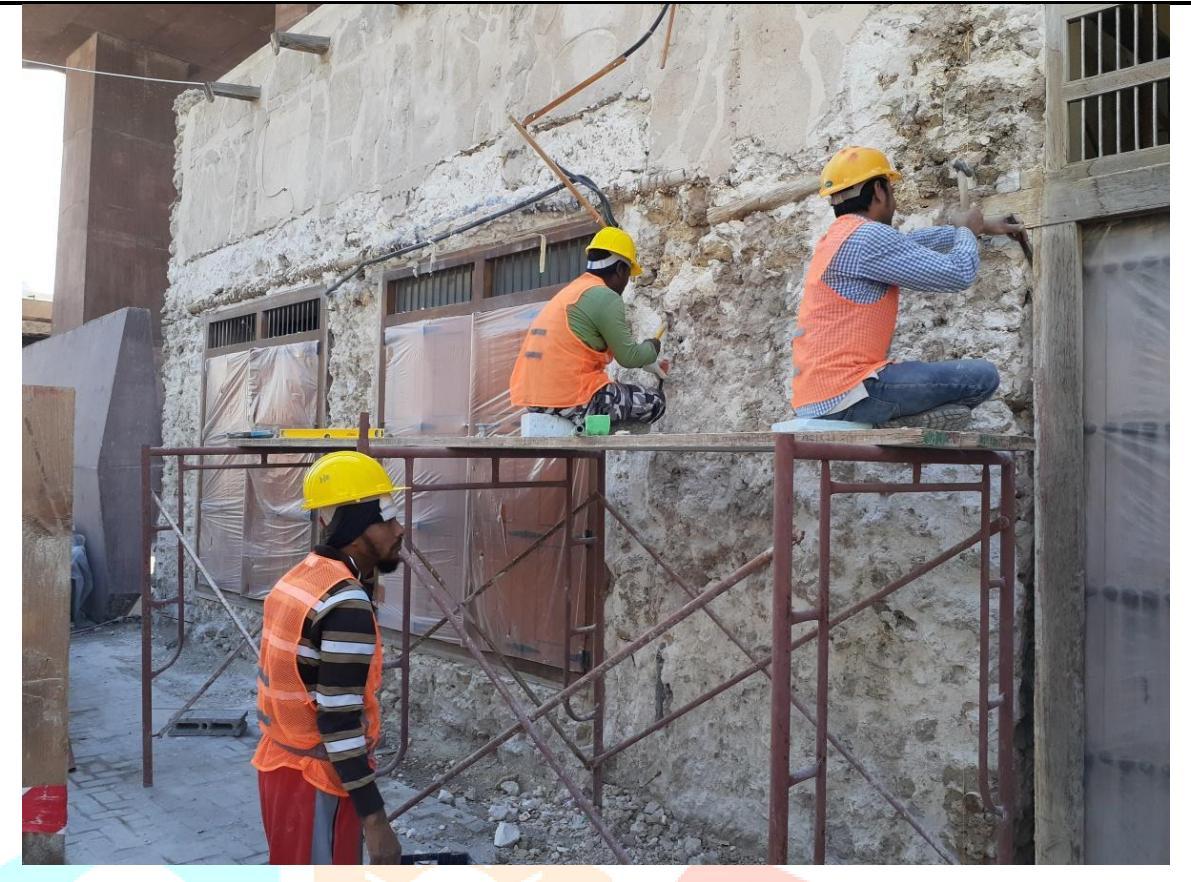
Fig.2. Removing of pre-existing plaster.

Following this, the damaged and superficial cement and gypsum plasters were mechanically removed (Fig.2). The damaged areas like pillars, walls, beams and other deeply damaged spots were filled with pavement stones and consolidated by adding hydraulic lime mortar. A layer of plaster using 'ROFIX plaster material' was added as per the guidelines. After this the old plaster will reach the required level for cleaning, on which ethyl silicate is used to stabilise the final state of the old plaster (Fig.3) (Yarwood, 1999).

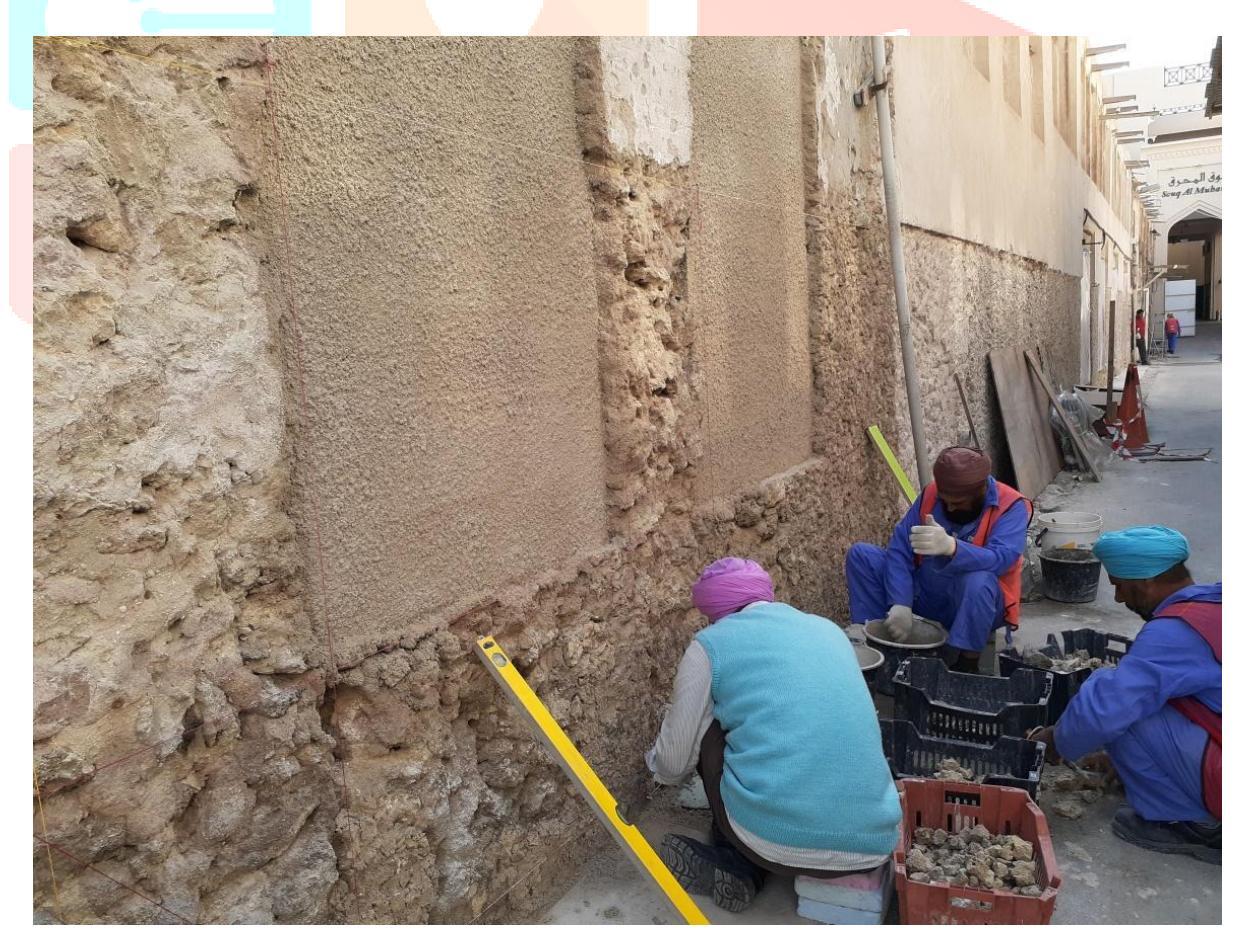
Fig.3. Application of plaster in damaged areas.

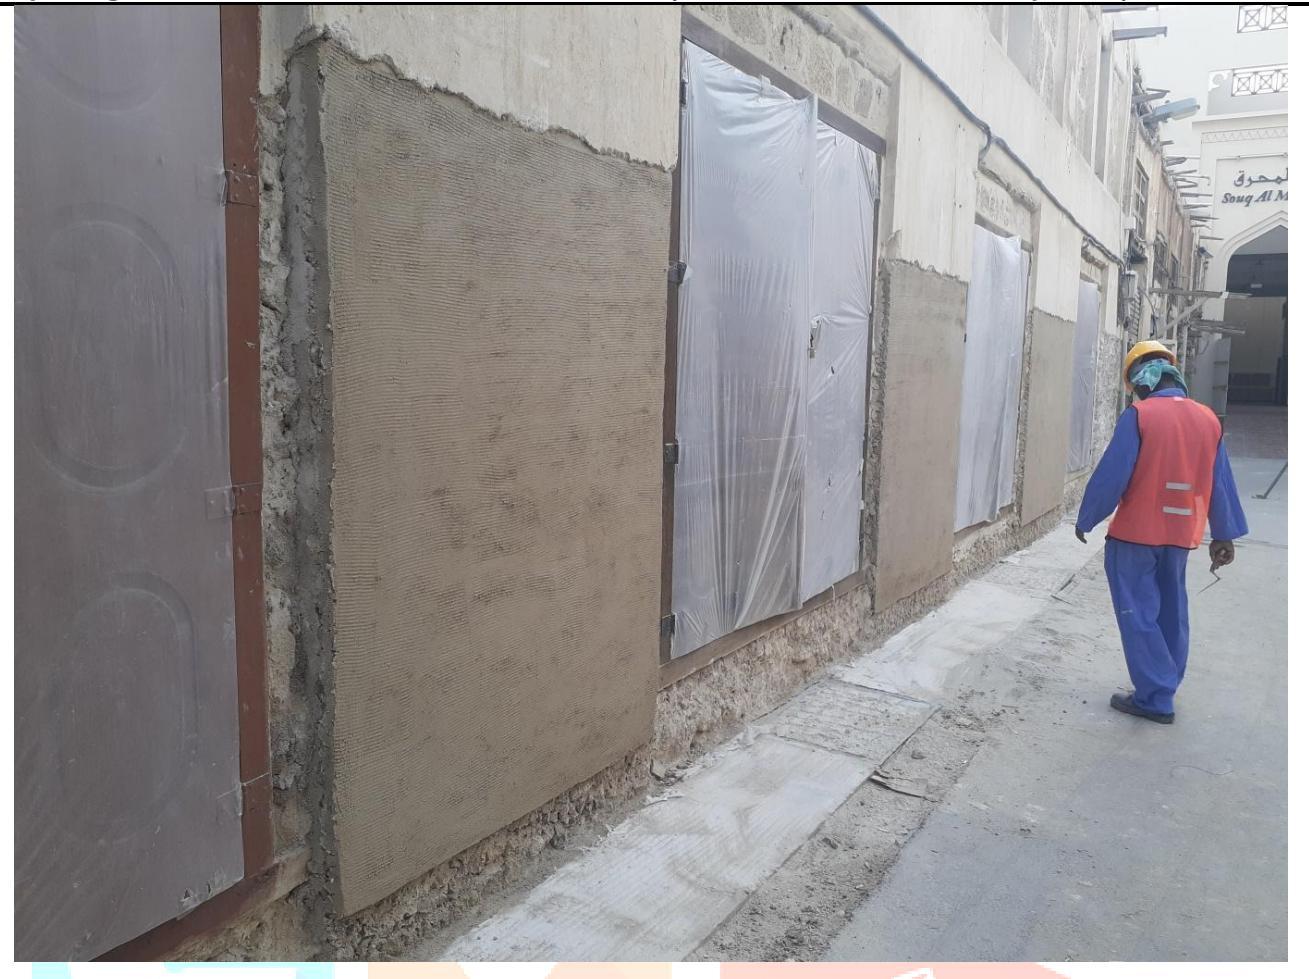
Fig.4. After the structural conservation of the walls.

All the wooden elements of the structure were first dry cleaned by using soft brush and a vacuum cleaner. Then chemical cleaning is done using rectified spirit and ethanol. The paint layer on wood is removed by using SM-10(paint remover) as suggested by the conservation guidelines (Nanda, 2017). After cleaning the wooden elements, a layer of protection is applied using a hot mixture of teak oil and turpentine in 1:3 ratios (Fig.4).

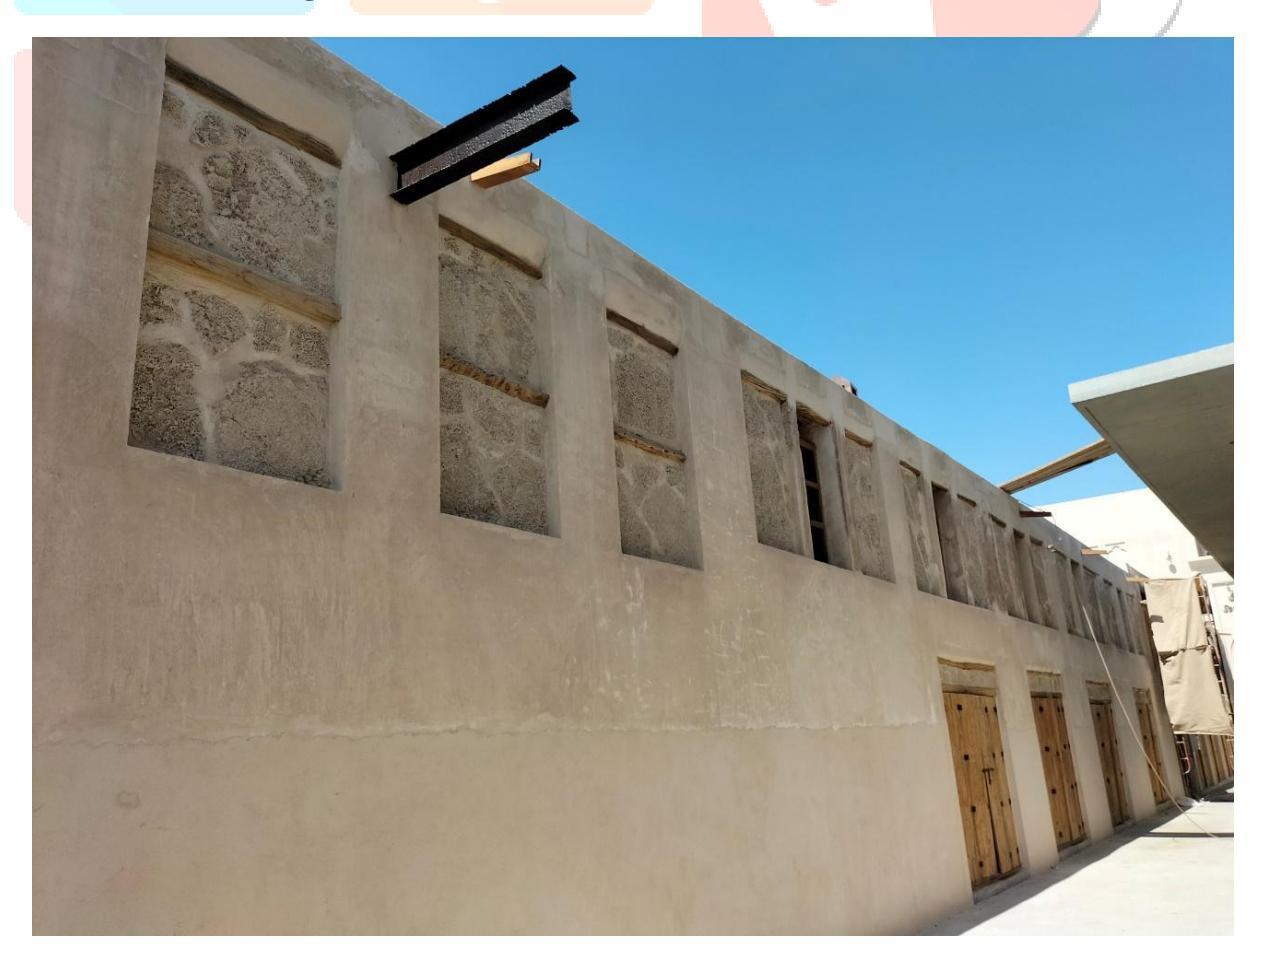
Fig.5. Final view of the structure after conservation.
