# Effect of Transverse Low Velocity Impact Damage on Torsional and Bending Strength and Effect of chemical reactivity of Hybrid Aluminium/Composite Tubes

Ravi Singh<sup>1</sup>, U.K. Joshi<sup>2</sup>,

<sup>1,2</sup>Department of Mechanical Engineering

<sup>1,2</sup>Jabalpur Engineering College, Jabalpur, India

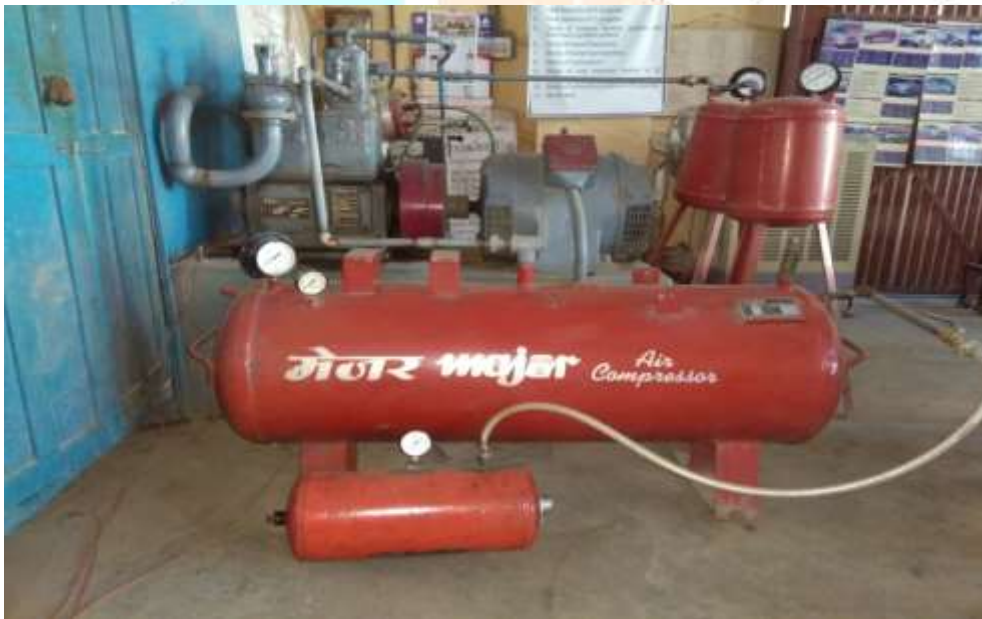
Fig.2: arrangement of compressor unit and pressure cylinder

parameters of the fibers are listed in Table 1 and in this table, cw & cf are the strand breath, and ew & ef are the gap between two consecutive strands. f and w superscript designate the fill and warp direction of the plain weave woven fabric, respectively. Araldite resin matrix material and Araldite hardener were used in this work in proportion of 2:1 by volume respectively. The arrangement of compressor unit and pressure cylinder is shown in Fig. 2. Specimens fabricated by above mention technique are shown in Fig. 3.

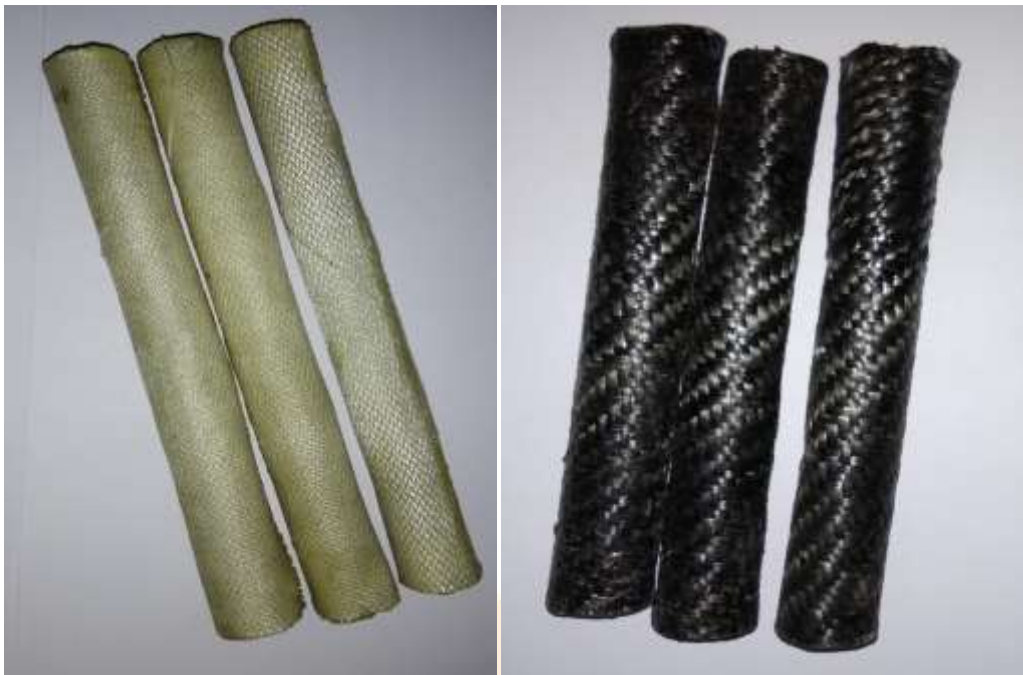
Fig.3: Specimens Fabricated by above Technique

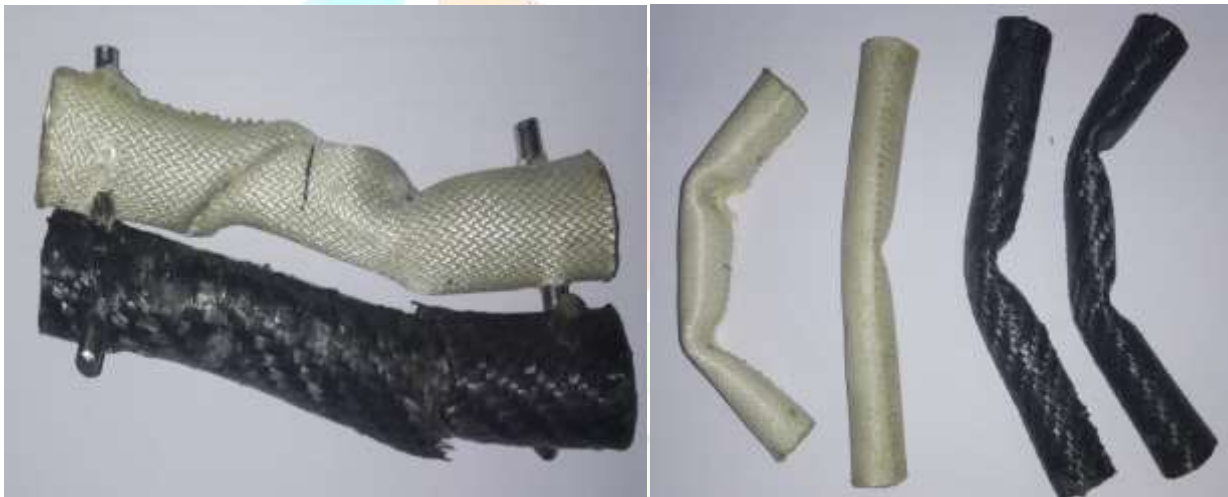
Fig.6: Specimens after torsion and Bending test Respectly

From the torsion test, it was observed that specimens without impact were fractured at gauge length and specimens with impact were fractured from impacted point, as shown by the drop of torque value. It was noted that first delamination of composite fiber layer occurs from the aluminium tube, then buckling of both aluminum and composite fiber layer seen during failure of hybrid composite specimen under torsion. Torque-twist angle relations were documented for all specimens. Figure a and b shows torque twist angle relationship for specimens without and with impact damage tested under torsion. Torque-twist angle experimental values for specimens without and with impact. The results obtained are given as follows:

One specimen with no impact damage and one specimen with impact damaged bare aluminum tube were tested under three point bending test, similarly done for hybrid glass and carbon tubes. During bending, the damage areas of specimens were kept in upward position. The end supports were considered simply supported and there was no slipping of the specimens over the supports throughout the bending tests. The load vs corresponding deflection of center point could be obtained from the three point bending tests. Load- deflection relations were documented for all specimens. Fig. 10 (a) and Fig. 10 (b) shows Load- deflection relationship for specimens without and with impact damage tested under 3-point bending. In this study, Load- deflection relations were recorded during the test until the applied load reached its maximum value and start decreasing. As load increases visible buckling of top surface and yielding of aluminum commence on the upper half of the specimens at the loading points.

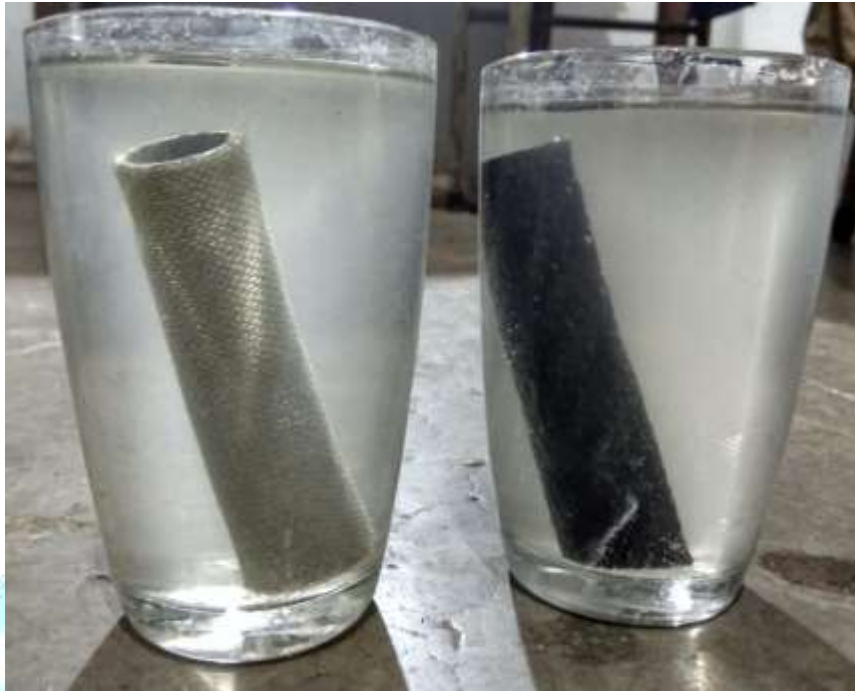
Figure .7: submerged samples.

As shafts are used widely in marine applications, resistance to corrosion and saline water is crucial. Chemical tests uses relative weight loss technique for determining reactivity. The behavior of fabricated shafts was investigated using brine solution. The solution containing approximately 3.5% salt was prepared and small samples of fabricated shafts were submerged in it. The samples were weighed before submerging and extracted after one week and were weighted again. Weight loss gives the extent of chemical reaction as it directly relates reactivity with a brine solution.

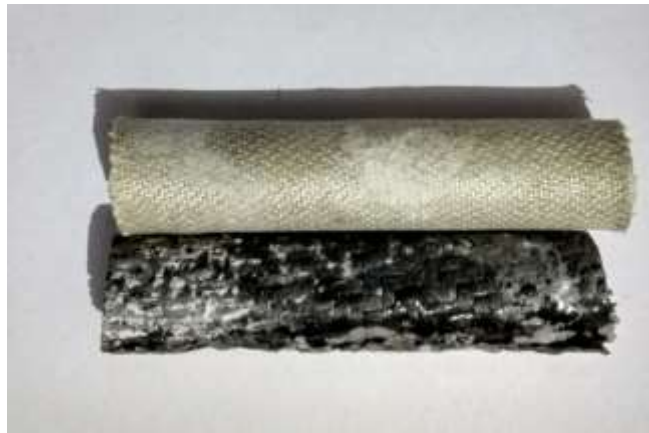
Fig.8: Specimens after NaCl solution

- Weight of specimen after 7days submerged in a NaCl solution
  - ✓ For Carbon fiber Al hybrid tube = 18.71 gm
  - ✓ For E-Glass fiber Al hybrid tube = 18.23 gm

- ✓ Change in weight(%) =  $[(18.23-16.74)/(16.74)]*100$
- ✓
- ✓ = 8.90% weight increased

- ✓ Change in weight(%) =  $[(18.71-16.94)/(16.94)]*100$
- = 10.45% weight increased.

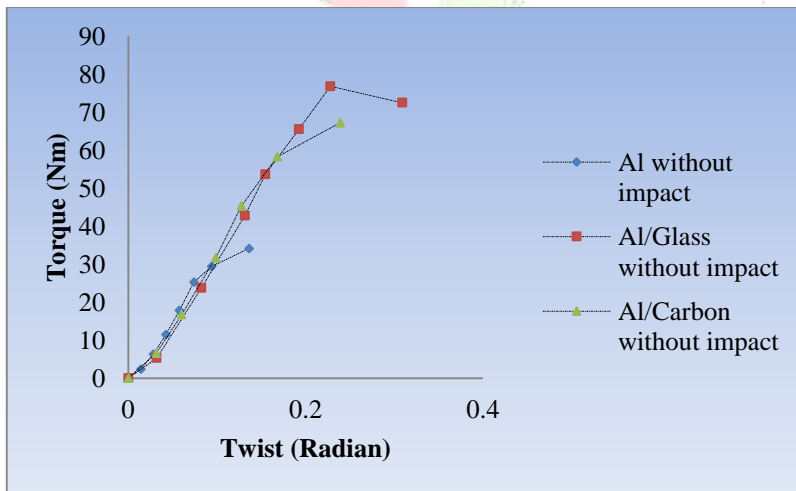
Fig.9: Comparison of torque -twist angle relationship for specimens without impact damage tested under torsion.

- ✓ Bare aluminum tube with and without impact damage endure maximum torsional load of 23.25N m & 35.8 N m respectively and maximum twisting angle of 5.4° & 7° respectively.
- ✓ Hybrid aluminum/E-glass composite tube with and without impact damage endure maximum torque of 61.2 N m & 80.6 N m respectively and maximum twisting angle of 12° & 14.5° respectively.
- ✓ Hybrid aluminum/carbon composite tube with and without impact damage endure maximum torque of 49.6 N m & 69.7 N m respectively and maximum twisting angle of 9.7° & 13.5° respectively.

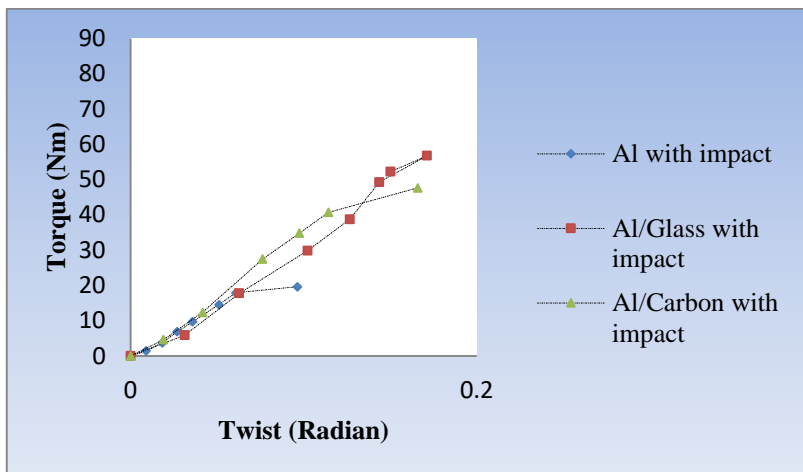
Fig.10: Comparison of torque -twist angle relationship for specimens with impact damage tested under torsion
