STUDY OF A ROAD WIDENING PROJECT IN HILLY REGION AND ITS IMPACT ON ENVIRONMENT: KUMAUN HIMALAYA, UTTARAKHAND

6.0 FIRST PHASE OF ROAD WIDENING FROM KAKRIGHAT TO KHAIRNA

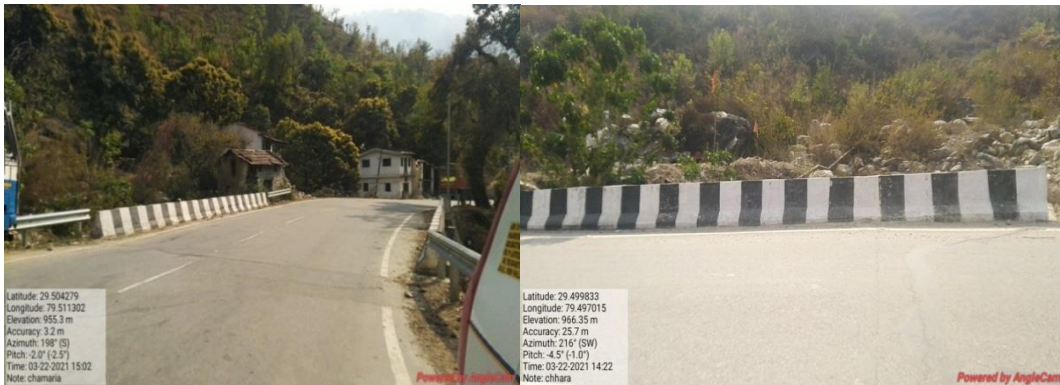
Plate 2: Minor bridges (source: field survey)

6.1.3 Construction of Minor Bridges- Three minor bridges constructed along the road included in this project lie near Chhara, Chamria, and Jaurasi. Stones and other materials used in the structure and sub-structure are mostly part of the material mobilized during the widening process. The width of these bridges is 6.20 to 5.25 meters. Details about these bridges are mentioned in (Fig.3, Table 1, and Plate 2).

S. N.	B ridge location	Salient details of existing bridge				Adequacy
		Type of Structure				
		Foundation	Sub-structure	Super structure	No. of spans With span Length(m)	
1	Chhara	open	Stone masonry	RCC solid slab	1x8.50	adequate
2	Chamria	open	Stone masonry	RCC solid slab	1x9.55	adequate
3	Jaurasi	open	Stone masonry	RCC solid slab	1x9.55	adequate

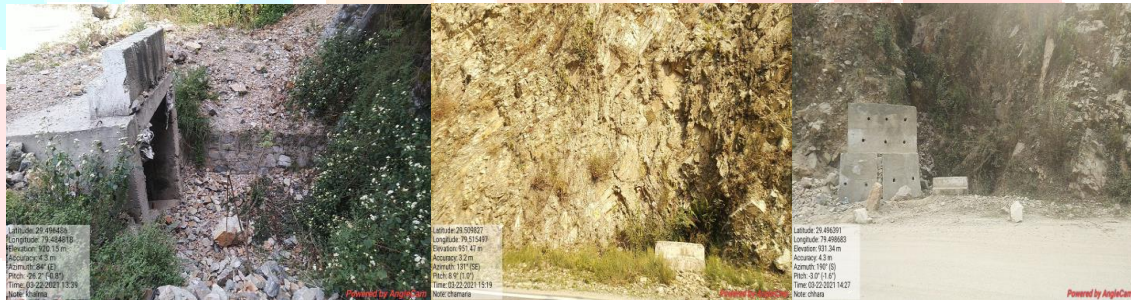
Plate 3: Roadside culverts (source: field survey)

6.1.5 Construction of Culverts- In this road project, several culverts have been built between Khairna to Kakrighat. They are constructed by stone. The details of the culvert are mentioned in Fig. 4 and Plate 3 that the data was provided by NH Office Haldwani.

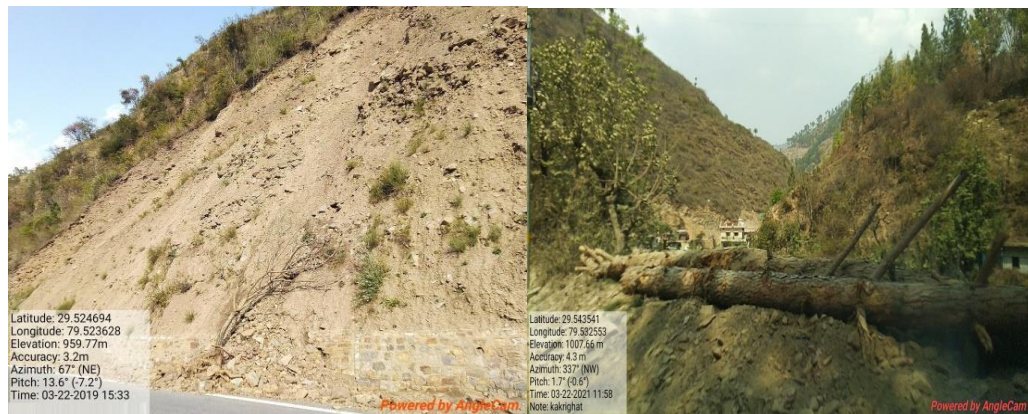
Plate 6: Effect of road widening on vegetation (source: field survey)

Vegetation is one of the most essential elements of the environment. Most of the forested areas have lost their significance and at places existence due to urbanization and uncontrolled construction. While on the one side, the environmental protection agency is planning a green highway to sustain ecology, and on the other side in the hilly region of Uttarakhand, much vegetation has been affected in the highway widening project. Deforestation is a major contributor to landslides. After the Indo-China war in 1972, highways were strategically constructed throughout Uttarakhand. In which many forests were affected due to the availability of road transport (Ravi Chopra, 2014). According to the data of NH Office Haldwani, the road widening project between Khairna to Kakrighat affected 4.2 hectares of forest area and 0.78 hectares of naap land. In which 0.79 hectares of reserved forest has been affected, 1.6 hectares of state forest has been affected and 1.77 hectares of civil forest/panchayat forest has been affected in road widening from Khairna to Kakrighat. A total of 4.2 hectares of the forest area has been affected by road widening (Table 2). The forest department received a budget of 69.5 lakhs to cut 4.2 hectares of forest area. The forest department had also appealed for 23583.0 lakh funds for the dumping zone from Khairna to Kakrighat. Approximately 1577 trees have affected under 10 km area between Khairna to Kakrighat. The forests damaged due to road widening can cause disasters. However, there is a provision for doubletree planting in the area of tree felling. During road construction work it is necessary to compensate for cutting down the forest on the roadside. It is mandatory to get permission from the forest department to cut the trees required for road construction. Compensation for the loss of trees in road construction is necessary as per the rules of the forest Department. These are just in the form of documents. This highway project extends from Jyolikot to Karnprayag. In which many flora along the road will be affected (Plate 6). This effective forest area falls under Almora and Nainital districts.

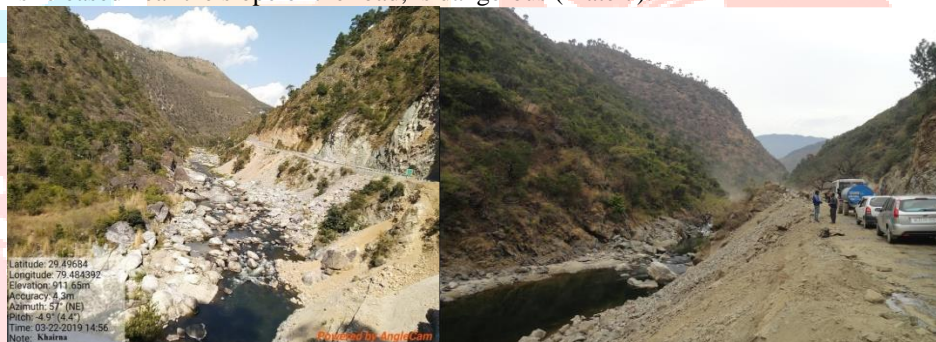
Plate 7: Debris dumped near the slope of the road, which is blocking the river (source: field survey)

The Kosi River runs through this road widening area From Khairna to Kakrighat. The road passes by the banks of the Kosi River. The debris of the road widening has entered the river from the slope of the road, blocking the flow of the river. During the rainy season, all the loose debris gets into the river. This process interrupts the flow of the river at various places. Whereas the rule is that, the mobilization of the debris must be to the dumping zone, which should be 100 meters away from the construction area. However, the debris, which is released near the slope of the road, is dangerous (Plate 7).

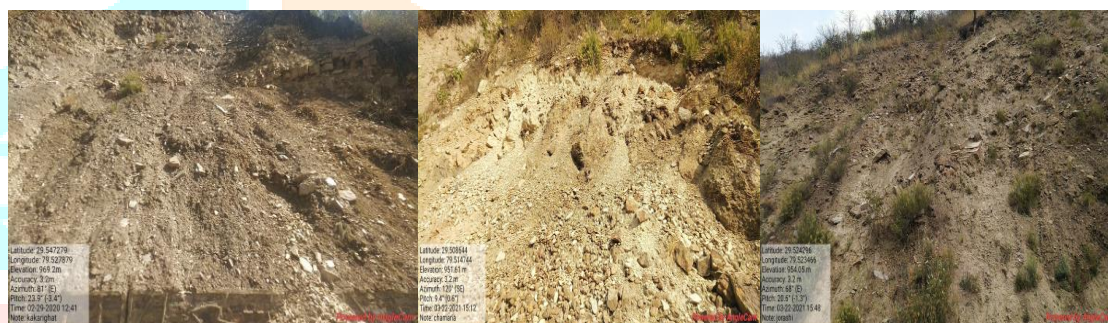
Plate 9: New landslide area (source: field survey)

There is a steep and moderate slope between Kakrighat to Khairna in NH 109. The slope cuts to widen the road move the grip rocks and soil has become loose, due to which the rocks are falling on the side of the road. This process increases new minor landslide areas in the future, it may convert into a high-risk area. Similarly, the hill slope in Kakrighat cut up to 80 meters, affecting the hill slope. Heavy boulders fall in this area anytime. Somewhere the cutting of slope becomes a cause of landslide by humans that will lead to environmental problems in future.

S.N.	Landslide Symbols	Location	Area (square meters)	Map Length (Meter)	Ground Length
1	L1	Kakarighat	1508	32.18	43.35
2	L2	Kakarighat	5405	53.38	73.41
3	L3	Jaurasi	427	14.07	21.67
4	L4	Jaurasi	2207	26.4	31.91
5	L5	Chamria	3163	63.09	97.54
6	L6	Chamria	8714	229.36	296.69
7	L7	Chamria	5535	154.17	205.13
8	L8	Chhara	67.4	5.73	9.26

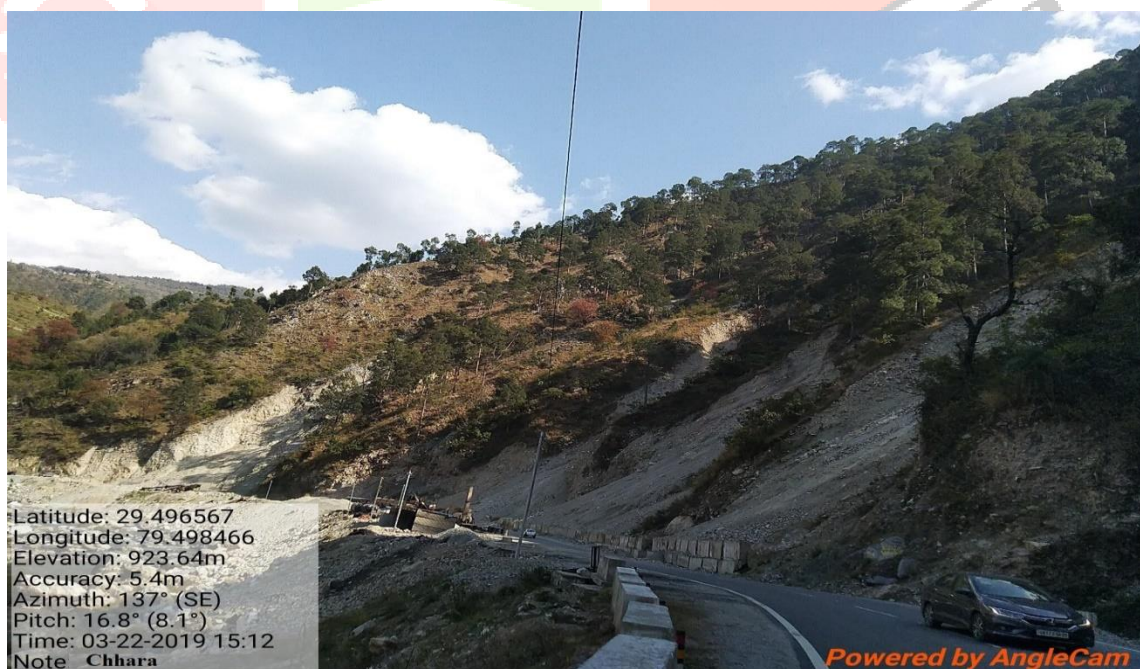
Plate 8: Old landslide area near Chhara (source: field survey)

S.N.	Landslide Symbols	Location	Area (square meters)	Map Length (Meter)	Ground Length
1	L1	Khairna	2035	49.92	57.31
2	L2	Chhara	1,03,402	376.23	496.53
3	L3	Chamria	5535	154.17	205.13

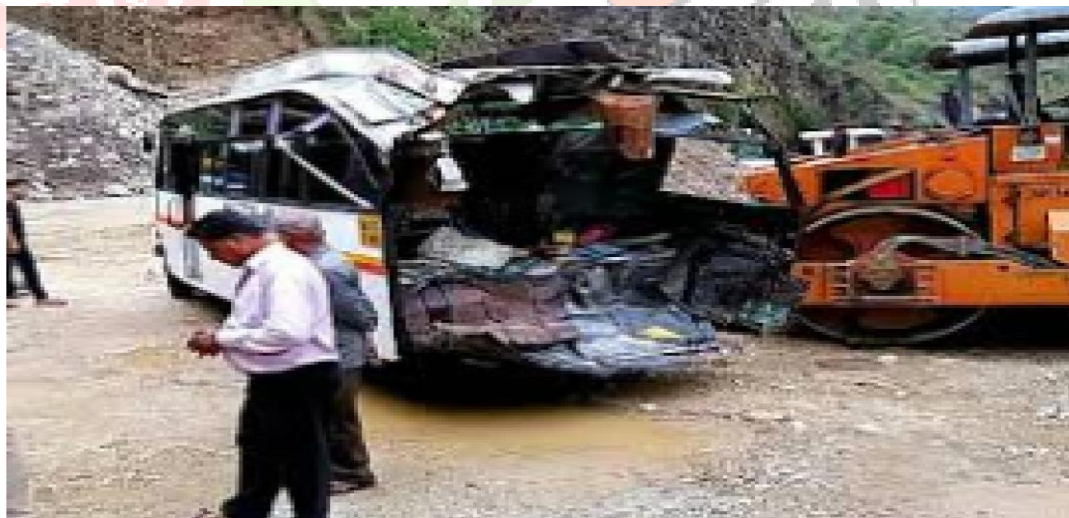
Plate 10: Bus badly damaged due to boulder flow (source: field survey)

The road widening project severely affects human activities, especially in the hilly region. Due to road widening, there landslides are increasing on the side of the road, which are the cause of the accidents. The site has several locations with risky areas where bolder flow is common. Debris flow during the rainy season is also a common phenomenon in the study area. In 2017, about 10 people lost their lives in road accidents in the study area. A bus was badly damaged due to the boulder flow which killed 8 people (Plate 10). In July 2017, 2 bikers were buried in the debris due to the landslide. Khairna to Kakrighat road is completely risky due to the landslides. The road becomes more dangerous during the rainy season.
