SEISMIC STRENGTHENING OF EXISTING REAL STRUCTURES WITH FUTURE EXPANSION AS CASE STUDIES

Index Terms : SEISMIC STRENGTHENING, EXISTING REAL STRUCTURES, FUTURE EXPANSION CASE STUDY

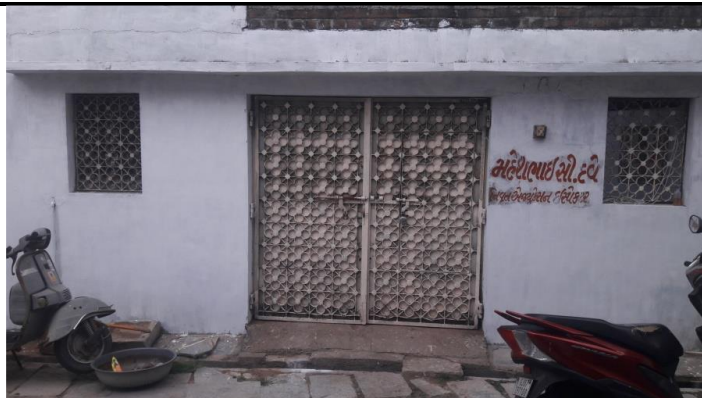
Fig 24 Timber Lime Structure

This timber lime structure was constructed 250 to 300 years ago with the locally available material like lime & imported ‘Malbari saag’ which is popular for sustainability serviceability & lifelong Ness. This timber lime haveli is having wooden art work same as old heritage structure at the beam column joint as well as the door & window frame. This healthy structure got minorly damaged in Bhuj earthquake 2001but it gave birth to many difficulties. In2019 one of the timber lime column got separated from the wall. The kitchen cum bed room beam got deflected & the open space smaller side secondary beam got cracked decayed. So to stand with structure after 2 years of lack it is compulsory to take the action. Regarding the information from the owner of the house no drawing is found.

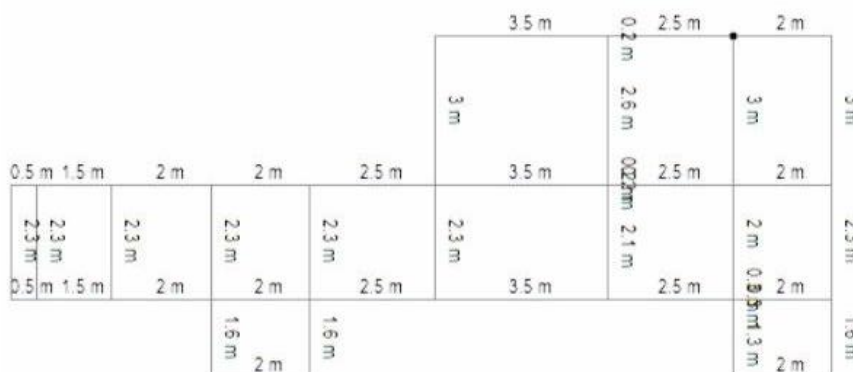
Fig 26 Plan Of Existing Old Heritage Cum Timber Lime Structure

Plan size=6.9m m x 17.5m
 Frame: timber
 Floor: two floor + roof
 Column size=0.20m x 0.20
 Slab thickness=1000mm
 Type of wall infill=red brick (‘patla cant’: rectangular in shape & 1.5time greater than standard modular brick)
 Size of wall=0.45m
