STRENGTHENING OF COOLING TOWER BY SHOTCRETING–CASE STUDY

RCC Cooling Tower of about 18m height is located in an aluminum factory at Angul, Orrissa. This comprises of RCC Columns, Walls, Side Loafers, Slab and also RCC dome. The purpose of cooling tower is to cool the hot water which is being sprinkled or circulated through it.

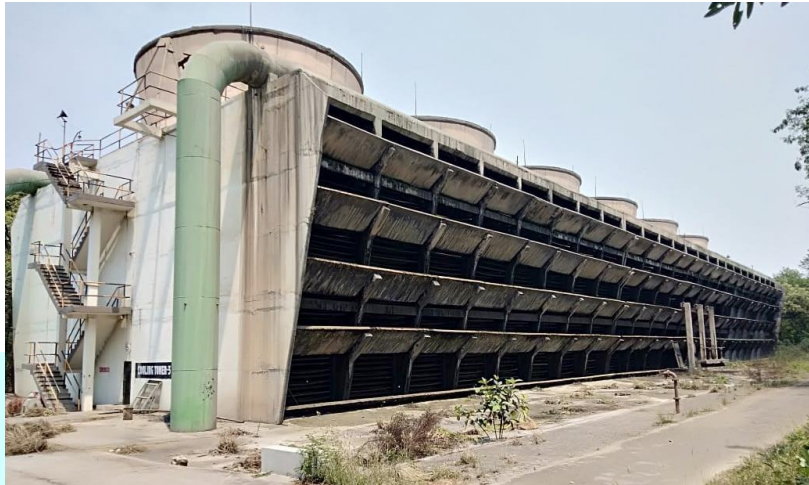
Figure-1 : Initial Condition of cooling tower

Due to continuous exposure to the moisture and due to the surrounding environmental conditions, at many locations the concrete got spalled and reinforcement got corroded & exposed.

Voids observed in the concrete members at the column-beam junction portions and at underside of the slab.

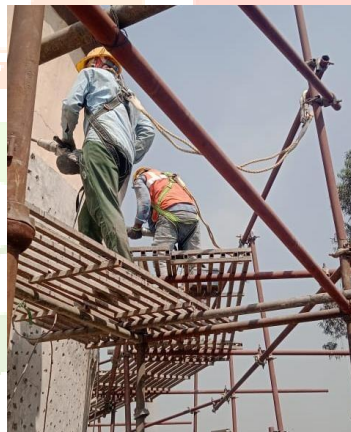
Figure -2

- All the loose, spalled concrete of the existing structural members waschipped off. Figure-2
- The exposed corroded reinforcement was cleaned using wire brush to remove the rusted portion and then treated using zinc-rich anti- corrosive paint.

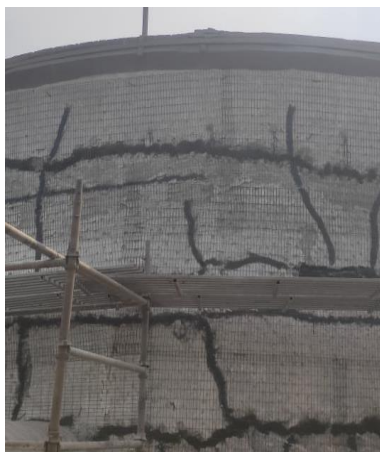
Figure -3

- The cracks & surface honey combings/cavities in the concrete members are sealed using epoxy sealant. Figure-3 . Also wire mesh fixed to the dome portion using shear connectors Figure-4.

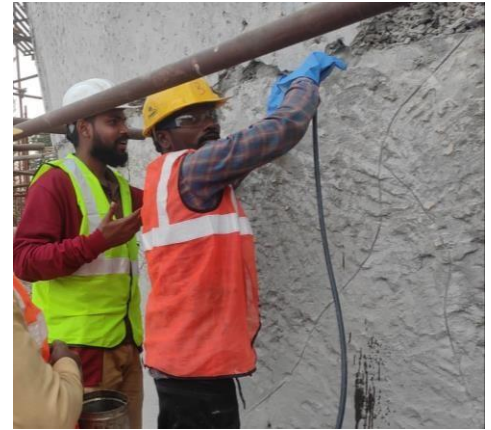
- In the areas of honey combing and voids, galvanized steel nipples are fixed and Epoxy grouting using low viscus epoxy material is carried out at low pressures. Figure-5

- ❖ At the areas of honey combings or voids, galvanized steel injection nipples of 12mm dia. to be fixed after drilling holes at regular intervals in the region.

- ❖ At low pressures, low viscous epoxy injection grouting to be carried out through the nipples
- ❖ The distressed columns are to be strengthened using micro concrete jacketing after suitable surface preparation and fixing of additional reinforcement.

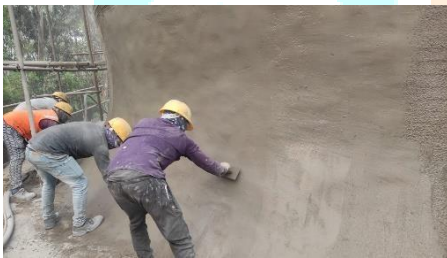
Figure -9

- After carrying out the repair activities by way of shotcreting, concrete jacketing and repair mortar, entire surface areas of the concrete members are treated using crack bridging water proofing coating and anti-carbonation coatings. Figure-9 , Figure-10 and Figure-11.

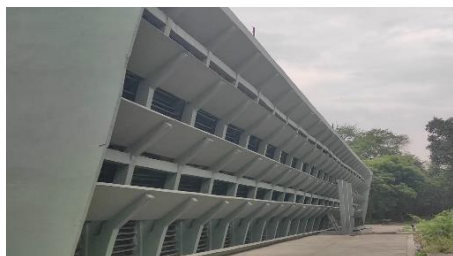
Figure -12

- Condition of cooling tower after strengthening: Figure-12, Figure-13 and Figure-14
