## Slope Stability Analysis With Batter Angle Variation

**Abstract:** A system was developed to identify the optimal highwall batter angle in an open pit mine. The initial design specified a batter angle of 70°, with the option to modify it in response to changing wall conditions as mining progresses from the northern to the southern sections. The mine has faced various challenges concerning slope stability, especially in regions with significant jointing and faulting, leading to wedge and planar failures. To mitigate these problems, the high wall is being methodically surveyed as it is exposed. By leveraging the newly gathered data, slope stability is reassessed in light of mining experiences, with the goal of determining if the benefits of lowering the batter angle justify the additional costs incurred from mining extra overburden.

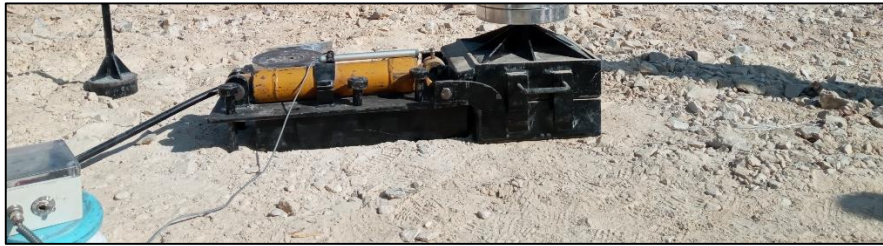
**Shear test block used for the study.**

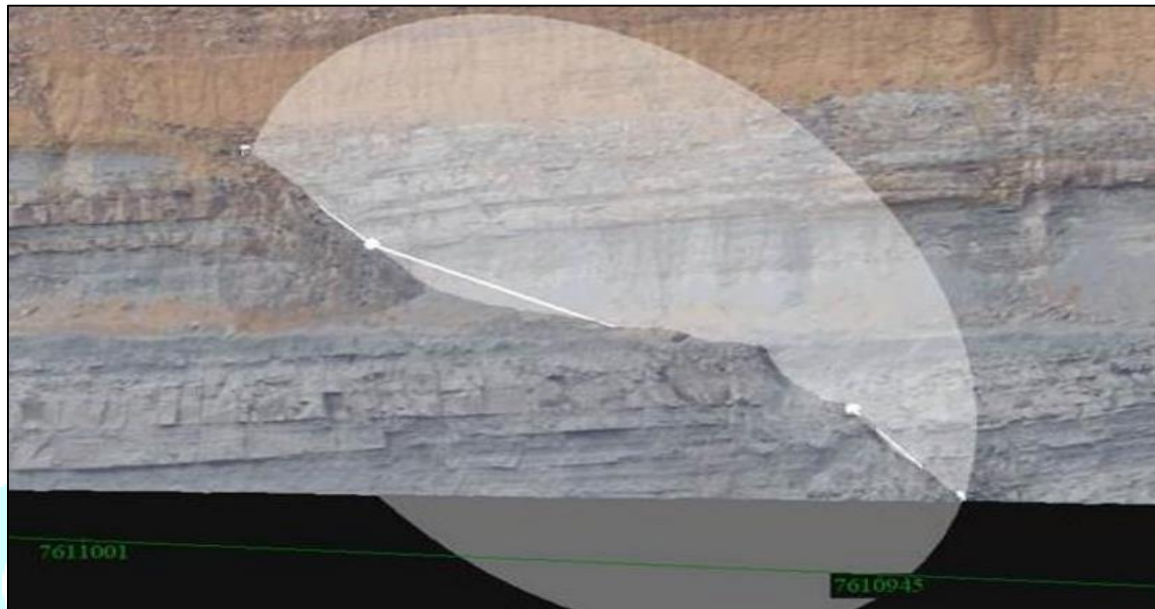
Defining Fault

Software was used to identify individual joints, measure their orientation and location, and derive their spacing (Figures 5 and 6). The data were transferred to the program Dips for further analysis. Much of the further analysis could have been done within Siro joint but in this case Dips was the tool of choice and it did not matter that locational information for each structure was lost.
