# Tackling Problems Of Waterlogging Occuring In Mysore Road (Kengeri) Due To Overflow Of Vrishabhavathi River

Adithya Hegade

PES University

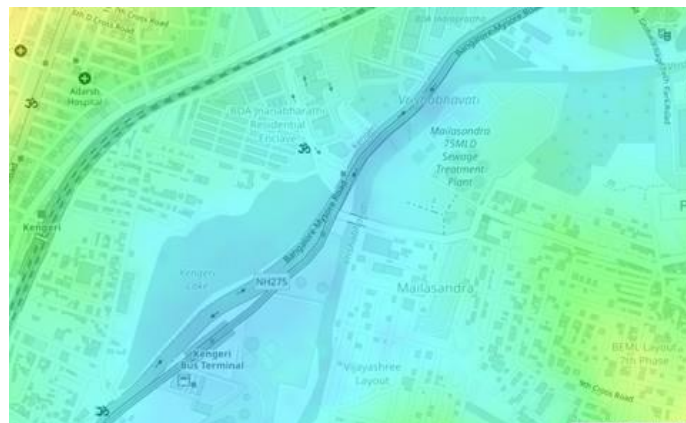
Fig. ii(a) Map of the site of study

780 - 795m elev 796 - 900m elev

- Maximum Elevation of Kengeri: 855 metres.
- Minimum Elevation of Kengeri: 765 metres.
- Average Elevation: 803 metres.

Highest point of elevation i.e., 855 metres is at the northern part of Kengeri. The site is located at an area which has one of the lowest points of elevation. Due to this, stormwater from throughout Kengeri gets accumulated near this area.
