A CRITIQUE ON THE NON- SCIENTIFIC CONSTRUCTION OF KEDARNATH AND POST DISASTER RECOVERY AFTER FLASH FLOODS 2013

Abstract: Kedarnath, one of the twelve Jyotirlingas, is an important Hindu pilgrimage. Kedarnath temple is believed to have been constructed in the 8th century. On 16 June 2013, the Uttarakhand State suffered a mega-disaster. The entire State was hit by very heavy rainfall and flash floods and among the 13 districts Bageshwar, Chamoli, Pithoragarh, Rudraprayag and Uttarkashi were the worst affected witnessing huge loss of lives, property and infrastructure. The reason for the destruction was claimed to be natural but it was evident that its non-scientific construction is equally responsible for the disaster. This paper aims at revealing the causes of the disaster and the recovery done by the government during and post-disaster.

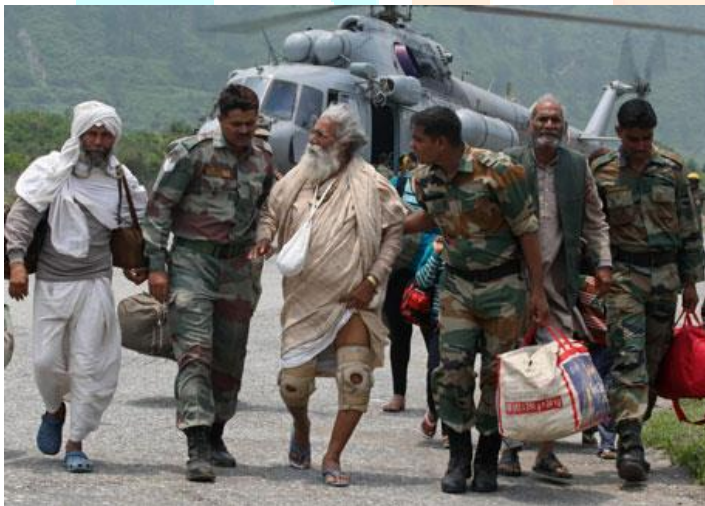
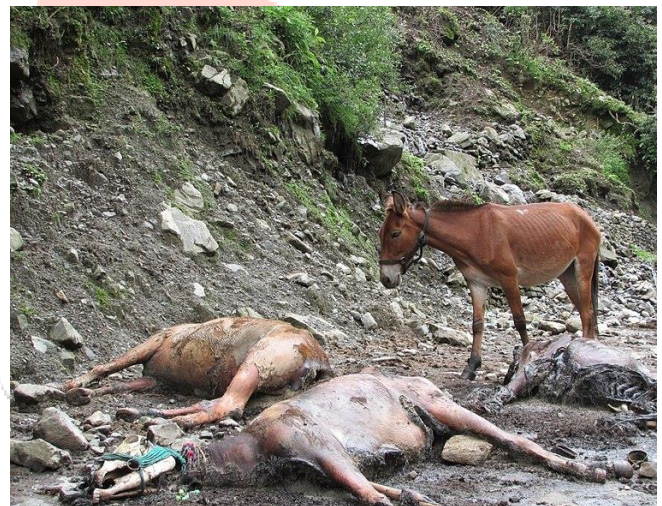
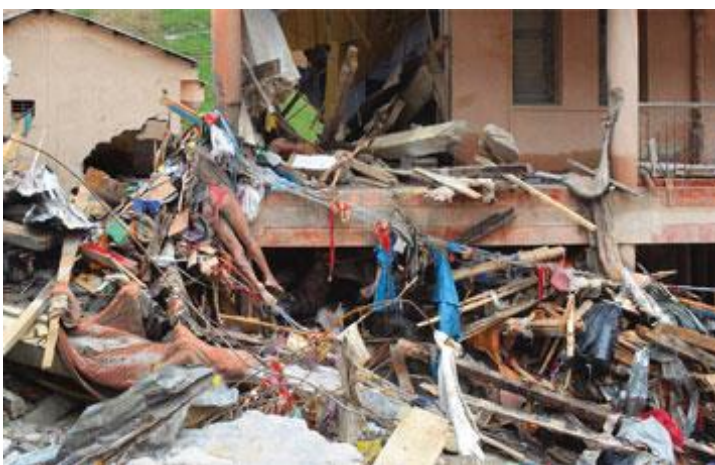
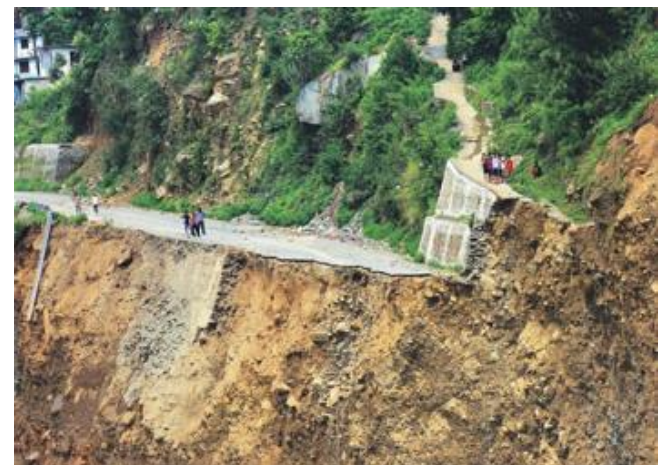
Fig 4. Damage done by Uttarakhand 2013 Flash Floods

The suddenness of the flash floods coupled with the high velocity of flow laden with heavy sediment, including boulders washed away pilgrims and locals. Apart from flash floods, people were also reported to be killed by landslides, which buried them alive under huge debris and rock falls. The difficult terrain and blockage of roads made it difficult to provide necessary relief to the survivors stranded at isolated locations. The harsh weather conditions i.e. continuous rainfall, chilling cold and non-availability of proper shelter/clothes contributed to the misery endured by the survivors of the disaster. [6]

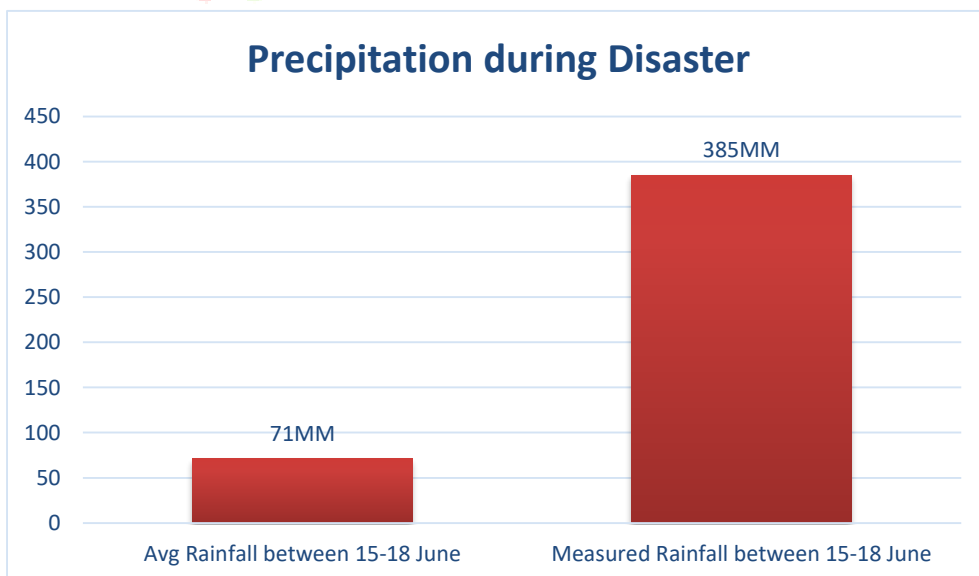
Table 3. Showing the rainfall comparison on flood day

As per the Indian Meteorological Department (IMD), the rainfall in the State between 15 June and 18 June 2013 was measured at 385.1 mm, against the normal rainfall of 71.3 mm, which was in excess by 440 per cent. Thus, it can be inferred that the disaster was the result of extra precipitation in a very short duration of time, which resulted in heavy water discharge in various rivers and streams.

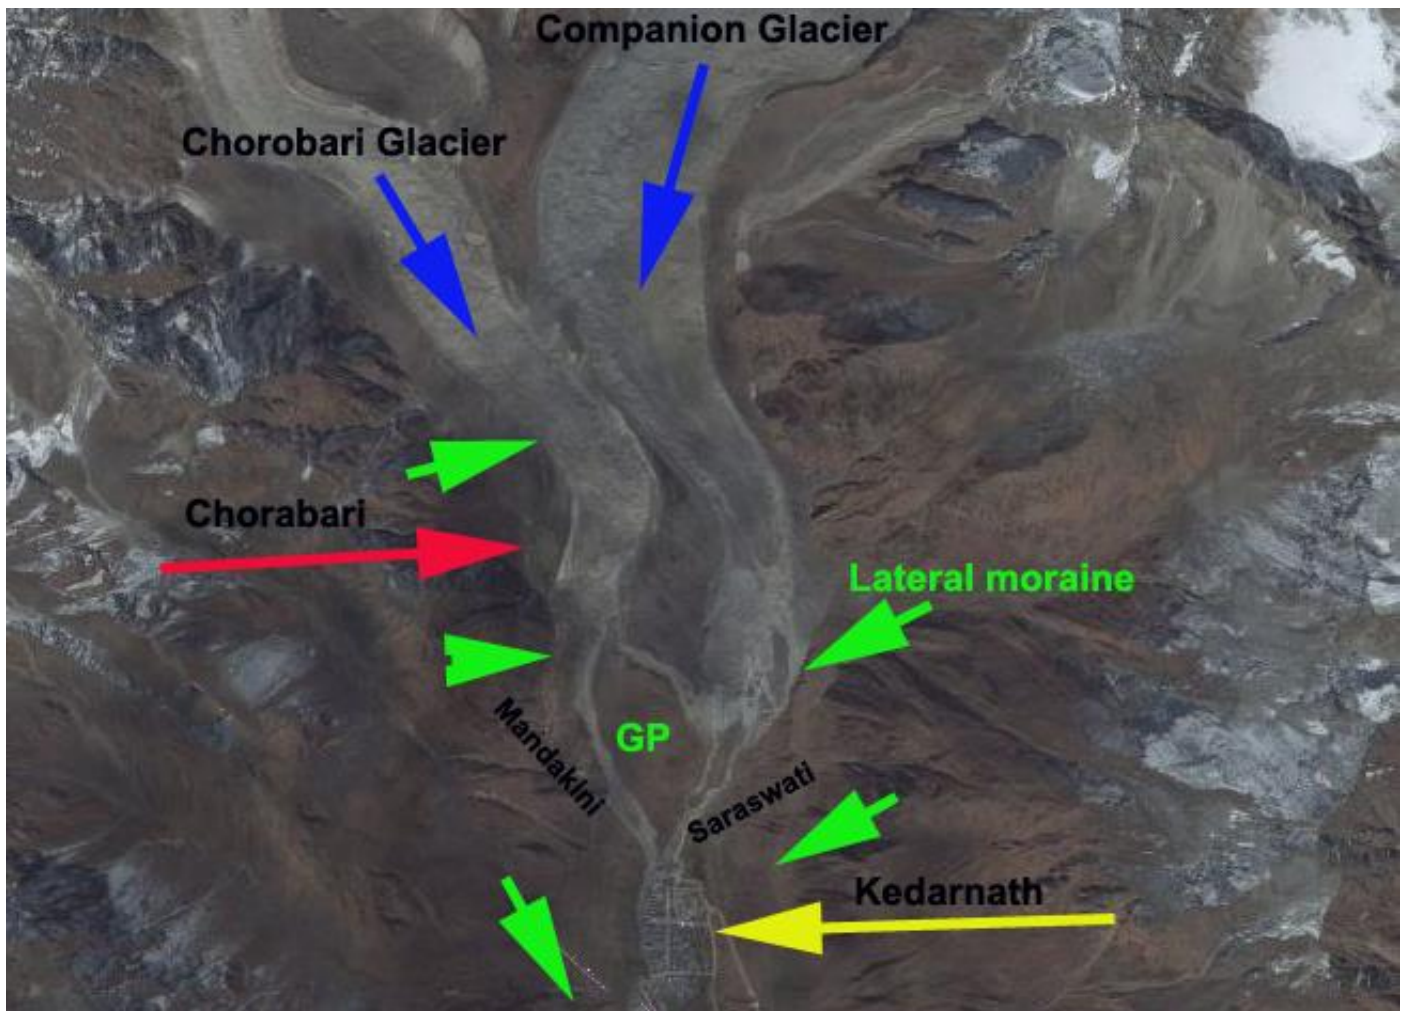
Fig 7. Satellite view of Kedarnath showing drainage system, glaciers, lake and township

A satellite view of the Kedarnath area, showing the Chorabari Lake, drainage system and the township is given at Figure 6. The river Mandakini joins river Alaknanda at Rudraprayag.

The likely causes for the disaster in the area of Kedarnath have been a subject of several assessments. As per the Geological Survey of India (GSI), heavy rainfall, which was about 375 per cent more than the benchmark rainfall during normal monsoon, caused the melting of Chorabari Glacier at the height of 3800 metres. This resulted into eruption of the Mandakini River causing heavy floods in the Rudraprayag district and adjacent areas. It was also observed that the heavy rains between 15 and 17 June resulted in exceptionally high rise in the river discharges. The rise in the river level was of the order of 5 - 7m, where the valley was wide and 10 – 12m where the valley was narrow. In the upper stretches of the Mandakini river the stream gradient is high and valley profile is mostly narrow. The gush of water running down from Kedarnath and Rambara areas brought mammoth sediment load which consisted of huge rock boulders with diameter ranging from 3 - 10m. The heavy sediment load along with big boulders acted as a tool of destruction and obliterated everything that came in its way. The enormous volume of water also induced toe erosion along all the river valleys, which in turn, triggered landslides at a number of places.

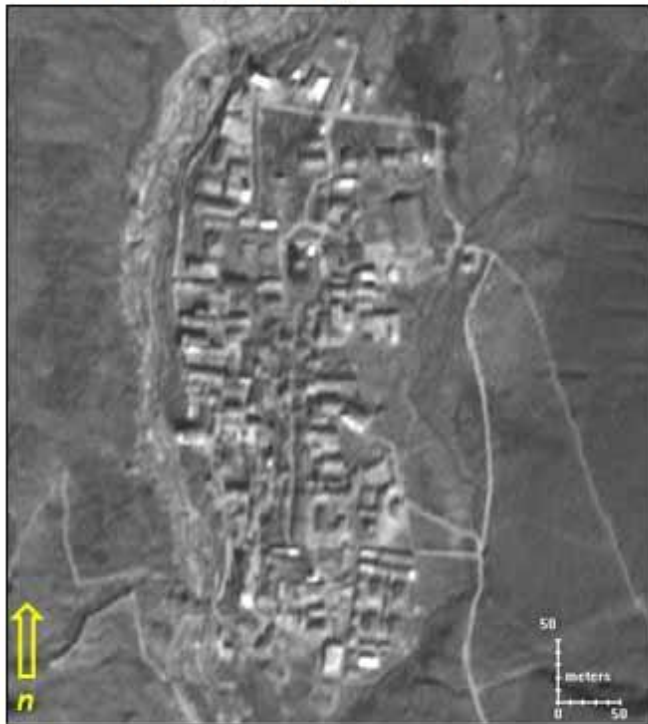
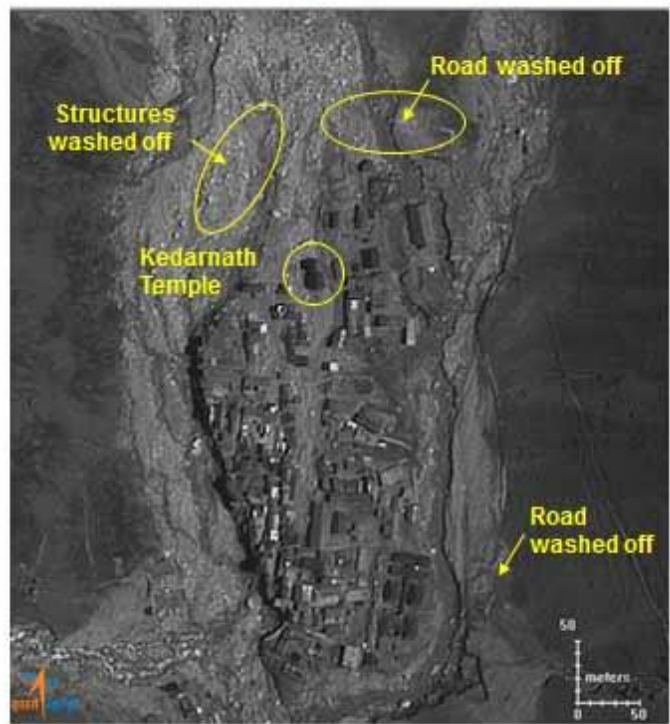
Fig 8. Satellite view of Kedarnath before and after flashfloods

CARTOSAT-1 image showing pre-flood situation

CARTOSAT-2A image of 20-June-2013 showing post-flood situation

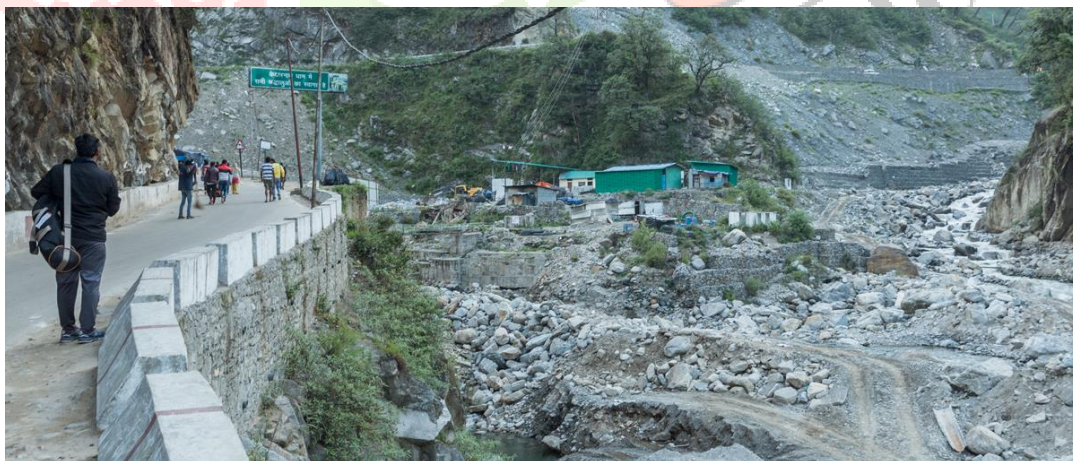
Haphazard, unregulated construction of roads and bridges was allowed on crumbling, landslide-prone ridges and steep slopes, ignoring the region's fragile geology and high earthquake vulnerability. Forests were destroyed on a large scale. Hundreds of buildings were constructed in the flood plains of rivers, their "natural" terrain, which should be no-go areas. Riverbeds were recklessly mined for sand. As construction debris accumulated, land contours and flows of streams and rivers changed.

Fig 9. Construction debris and activities along Mandakini River near the base from where the trek to Kedarnath begins

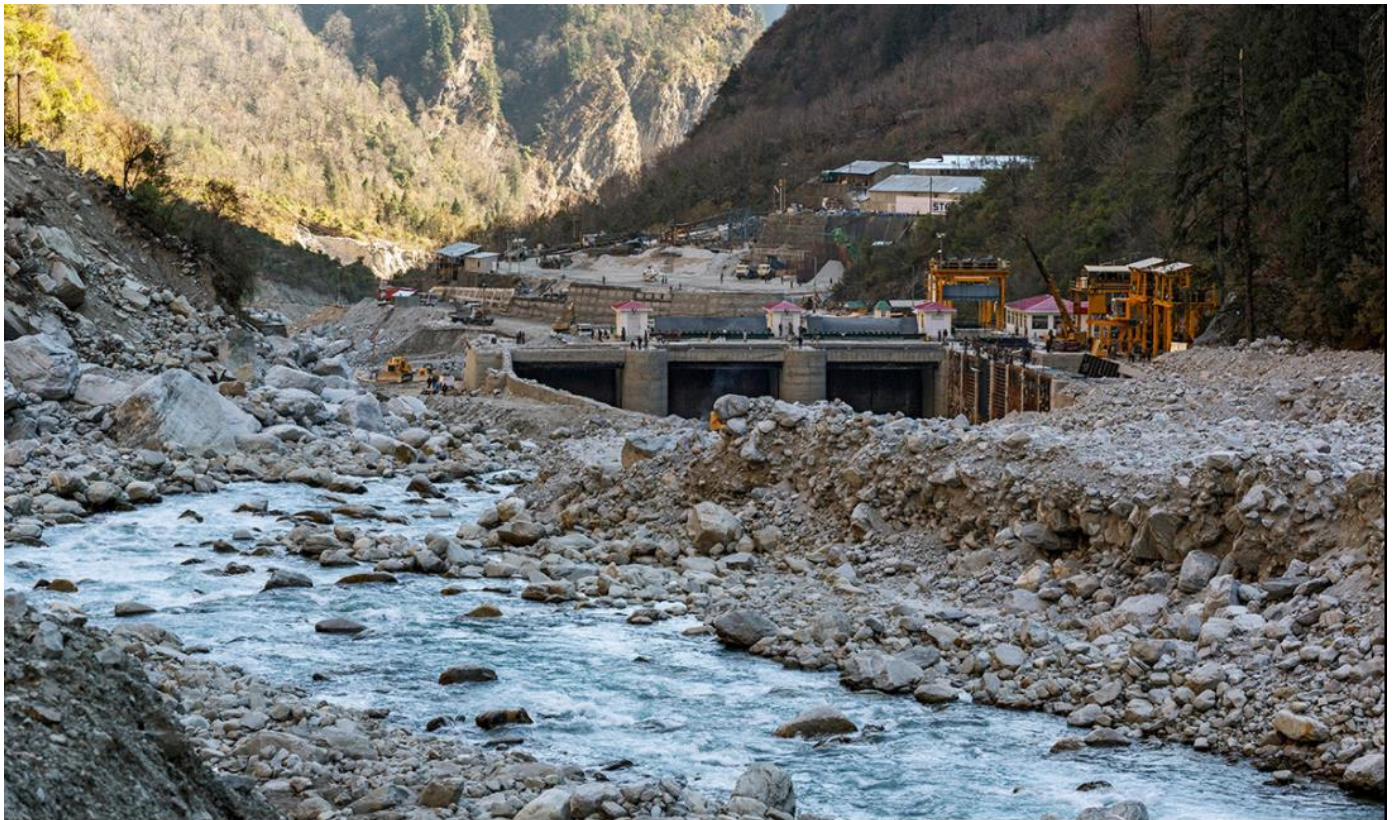
Fig 10. Vishnuprayag Hydroelectric Project on the Alaknanda River damaged by the flashfloods

The 400-megawatt Vishnuprayag Hydroelectric Project on the Alaknanda River was buried in mud & boulders, turning its backwater area for water storage into field of rubble. It took five months to dig this much of the dam out of the pile of boulders. [8]

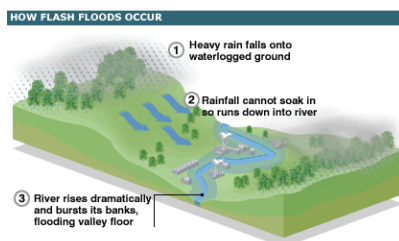
Buildings have been constructed over old drains and streams, blocking the natural pathways of rainwater. One of the reasons for the devastation at Kedarnath was the people had constructed houses on the west stream of the Mandaki River that had been dry for decades. When the river returned to its old course following the deluge, these constructions were washed away. Another transgression was construction on river flood ways. “In places along Alakananda/Ganga such as Karnaprayag and Rishikesh, constructions have taken place on the lower terraces which are part of the flood way. [9]

Fig 11. Illustration showing how floods occur

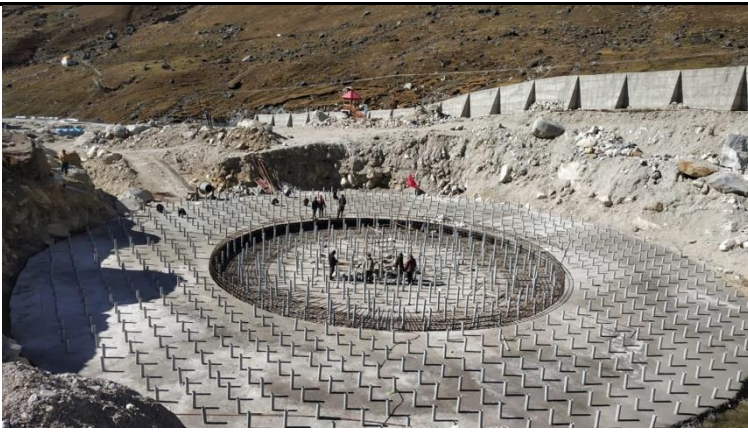
Fig 14. Sunken Samadhi Sthal of Shri Adishankaracharyaji

However the government has not shown keen interest and very few is done as compared to what's there in the proposal for the valley post the flashfloods. The construction of sunken Shri Adishankaracharya Samadhi Sthal behind the Kedarnath Temple is a matter of concern as it will become a catchment area for the snowfall and will put pressure on the valley. The deforestation for widening of roads and settlements may disturb the ecology and should be counter strategically by the executing bodies and the government as cutting of 33000-43000 of trees have already been given approval by the environmental ministry.

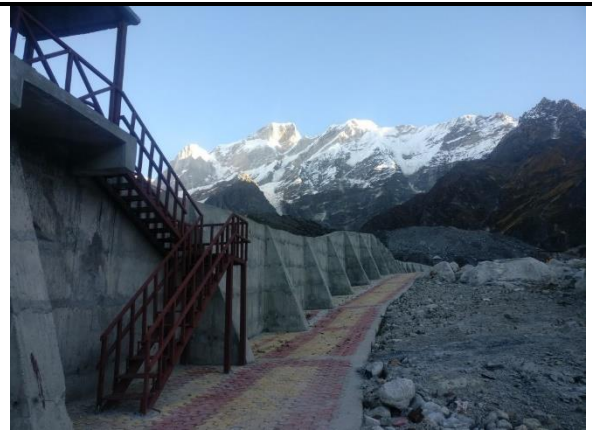
Fig 15. Retaining wall along Mandakaini River

- As part of the overall master plan for the Kedarnath, river edge protection is to be developed along this 350+ meter long river edge on eastern bank of river Mandakini. The proposed river edge Mandakini river will help in multiple ways; defining the flow of the river, protecting the soil from further erosion and providing platforms for views as well as providing Infra and Services path on the Western side of Kedarpuri. [10]
- In the second phase, the government would develop a new township at Lyncholi near Kedarnath and also a ropeway from Lyncholi to Kedarnath. All those buildings that have been declared unsafe at Kedarpuri will be demolished. The work for the stabilization of slopes will also begin.
- Construction of 9km long road across Mandakini river
