REPAIR AND REHABILITATION OF INDUSTRIAL STRUCTURE-A CASE STUDY

For determining the structural health of weir-house located in Mangalore port, as a case study first the complete physical inspection for that structure is done to find current situation of that structure so that further action can be decided. The data which is collected from the physical inspection is helped to determine the causes of deterioration. After the collection of primary data by physical inspection, collected secondary data from the respected office. Because the unavailability of all the data we carried out further detailed study using the available data. To find the exact present condition of structure we performed NDT and obtained the result, which gave the exact condition of the structure. Base on the obtained result we choose the further action to be performed. Obtained result is analyzed and concluded.

(General Details)

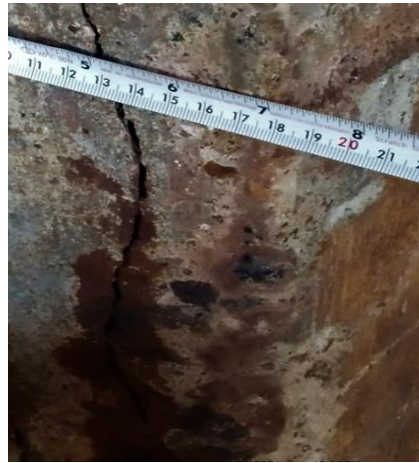
Wider cracks: The wider cracks are observed mainly on the vertical members(columns) which are caused by stress developed inside the column due to corrosion. These cracks are also even responsible for higher structural damage.

Wider cracks on Column

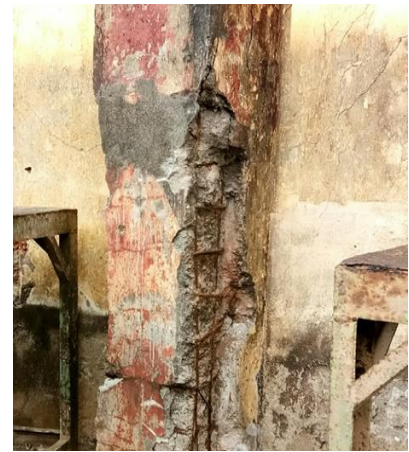
Corrosion: The corrosion of reinforcement is in high range on the exposed face of the structure which is directly responsible for formation of internal stresses inside the reinforced concrete members. The roof truss is also corroded completely and may fall any time.

Corrosion of Rebar

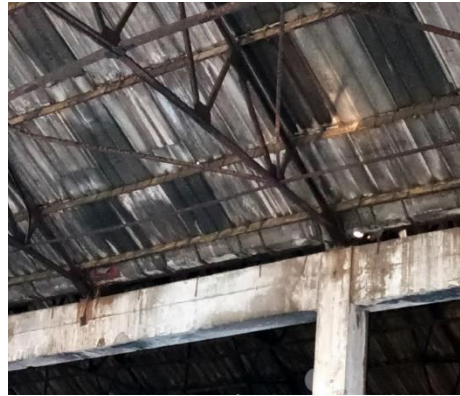
The proposed trusses are highly damaged due to corrosion and the bracing joints are broken as the proposed truss becomes more wrinkled and, due to high stress the truss started bending as well as bracing along with truss the roof sheets are also damaged and started spalling.

Existing Roof Truss

- It is noticed that, the roof of the existing structure was highly hazardous and the replacement is mandatory.
- The existing masonries are highly damaged and are significant for instant repair.
- The vertical members(column) lost their strength due to high range of cracks, spalling of concrete and internal cavity.
- The bottom portion of vertical members are impaired majorly as compared to other portions.
- The central columns are highly impaired and faced for quick retrofitting.
- The corrosion rate in existing RC members along with roof truss found to be extremely high.
- If the present condition's structure is left abeyance it will survive only for few years. Even if it is restored also it is temporary and is not such an economy.

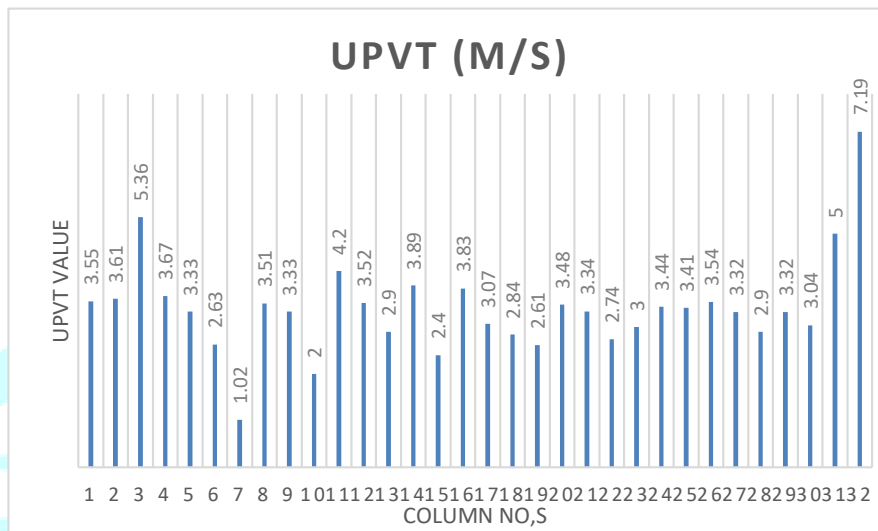
UPVT Mapping of Columns

EXCELLENCE	GOOD	DOUBTFUL	POOR
C3	C1	C5	C7
C11	C2	C6	C10
C31	C4	C9	C13
C32	C8	C17	C15
	C12	C20	C18
	C14	C21	C19
	C16	C23	C22
	C26	C24	C28
		C25	
		C27	
		C29	
		C30

While testing fluctuation in readings occurred due to presence irregularities in concrete such as internal cavity, larger cracks, debonding of concrete cover, lack of uniformity in the concrete etc. From the test UPV Most columns are in poor condition which requires sudden maintenance or reconstruction.

Most columns are in poor condition which requires sudden maintenance or reconstruction. The reinforcing steel present in concrete highly effects the measurement of pulse velocity because pulse velocity in a steel is 1.2 – 1.9 times the pulse velocity of the plane concrete.
