# Amu River Coastal Degradation Assessment Using Remote Sensing And GIS

## Abstract

**KEYWORDS:** RS, GIS, Amu River Basin, NDWI, LULC

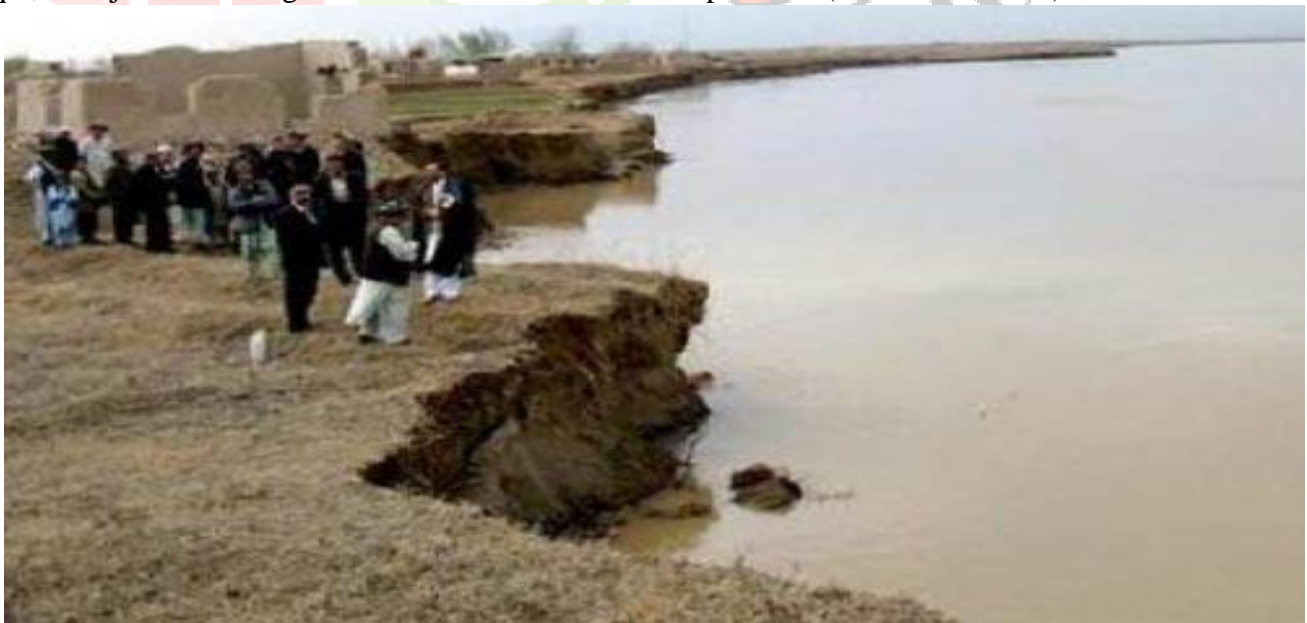
Fig.2 Amu River Basin Coast degradation photo by author.

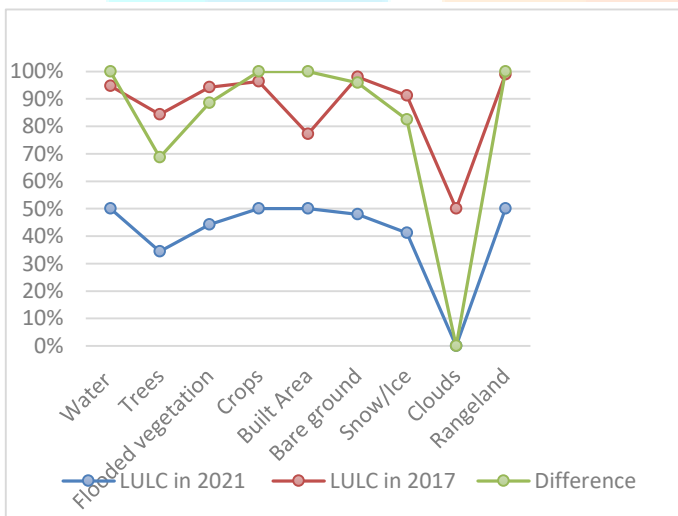
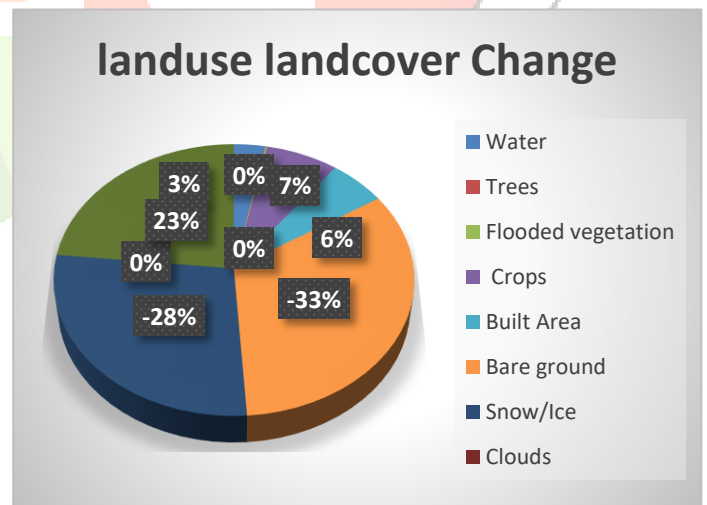
Figure.14 Percentage of Degradation of Land use & Land cover 2017-2021 Figure.15 Percentage of change in Land use & Land cover 2017-2021

In this study, Sentinel-2 10m land use/land cover classification was employed to prepare the study area's land use/ cover map. In this study, the best results were obtained Using this classifier, the Amu River basin was classified into nine land use/ cover classes: Water, Trees, Flooded Vegetation, Crops, Built Area, Bare ground, Snow/Ice, Clouds, and Rangeland. the study area was carried out in order to observe the relationship between the 2017 and 2021 change detection, which observe the value of water bodies increased and trees are other classes decrease because those are degraded by Amu River (Yuksel et al., 2008).
