STATISTICAL BASED AN INVESTIGATION OF FAILURE OF POWER TRANSFORMERS AND REACTORS

Shubham Vyas*, Vijay Yadav^

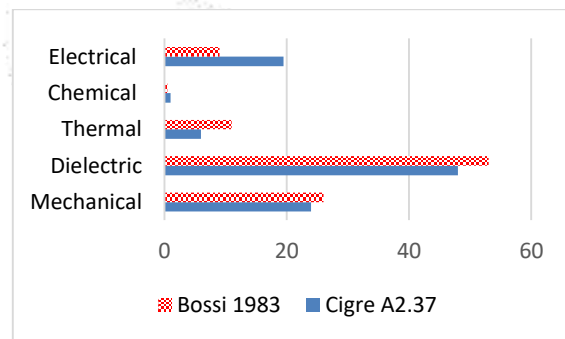
Graph 2– Comparison of failure mode in all transformer.

dates of manufacturing and the date of commissioning of transformers & reactors. i.e 36% was commissioned after 1 year of reached at site. During our investigation some catastrophic damages was observed at site, such as burst & fire of bushing and main tank. As per CIGRE [3] report which indicates that the most frequent source of transformer failure can be attributed due to tap changer, bushing, paper oil insulation and the other mounted accessories of transformer. Based on earlier studies, faults can be classified in five categories or modes & their percentage of faults are described in Graph 2 and Table 2.

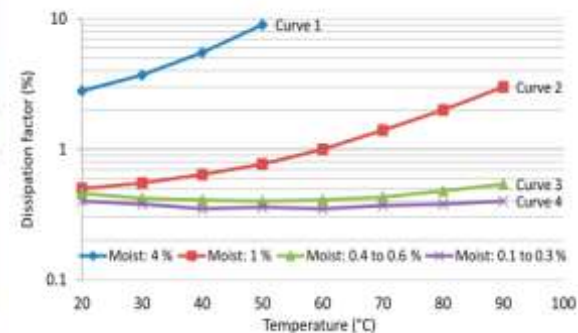
Graph 3- $\tan \delta$ as a function of temperature and moisture for OIP bushings.

Curve 1 for the moisture content of 4%
 Curve 2 for the moisture content of 1%
 Curve 3 for the moisture content of .4% to .6%
 Curve 4 for the moisture content of .1% to .3%

It can be observed from Curves 3 and 4 that the $\tan \delta$ remains almost constant at temperatures from 20 °C to 90 °C. For Curve 2, the $\tan \delta$ is 0.7 % at 50 °C and with a further rise in temperature the $\tan \delta$ shows a rising trend from 0.7 % to 3 % at 90 °C. Curve 1 shows that the $\tan \delta$ at 20 °C is as high as 2.8 %, but then abruptly rises to 9 % at 50 °C [6].

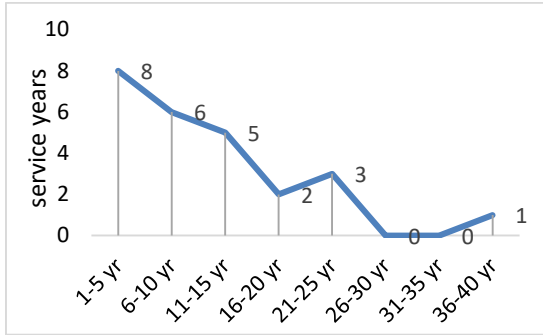
Graph 1- Transformers & reactor service life

Experts believe that failure increase with time span which is expressed by “Bathtub curve.” But available statistics have not yet revealed a correlation between the number of failures and proceeding years of service. In fact, the statistics show peak failures occurring around first 10 years after the transformer has been in commissioned, i.e 56% of the total data, Ref graph 1. From the records it is very clear that there is a big gap between

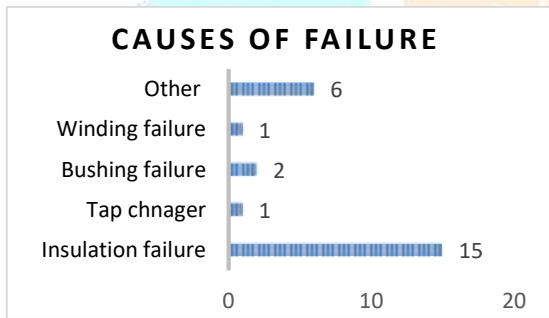
Graph 4 – Area causing failures

Failure data are further classified regarding to primary location of major failures i.e. failure of insulation, followed by other regions as ageing, long storage are the major contributors, refer graph 4. Mostly 220KV jobs was failed at site i.e. 52 %, refer graph 5. Avg life of 220kv, 400kv & 765kv is must lesser then its standard life, they are 13.1yr, 9Yr & 2yr respectively, refer graph 5. Specifically, Avg life of ICT is 10.8yr, GSU 15.3yr and reactor 5.7yr, refer graph 6.
