STUDY AND ANALYSIS OF PAVEMENT CONDITION OF HIGHWAY BY USING NETWORK SURVEY VEHICLE (NSV)

The highway section between Nagpur and Amravati on NH 53 Starts from Chainage Km 0+000 to Km 3+000 is selected for this study. . The total length of study stretch is 3 km.

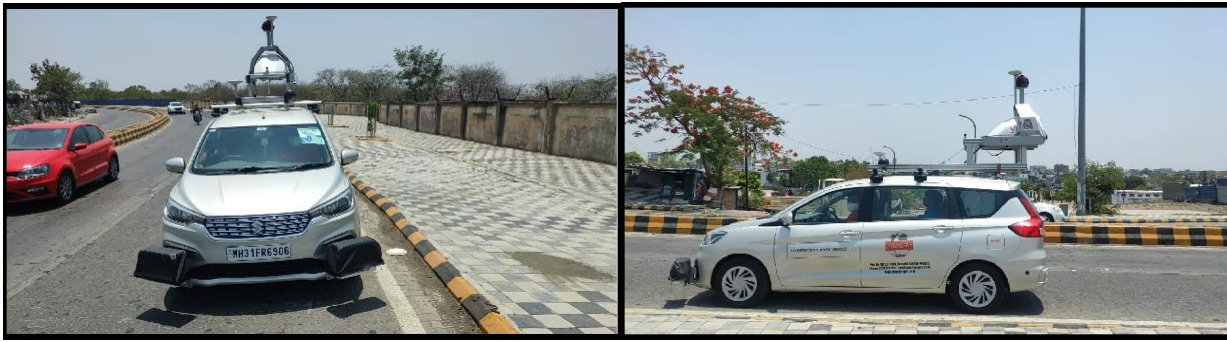
Fig 1.1 - (a) Front view and Side view of a NSV

Network Survey Vehicle is an innovative technology to inspect the existing pavement surface and collecting pavement high resolution imagery data, cracking, roughness, rutting, raveling, bleeding, texture depth, edge cracking, potholes measurement with LCMS, accurate distance measurement with distance measurement unit fitted at rear wheel, etc.

The Network Survey Vehicle is built on the most up-to-date survey techniques, including the use of lasers, GPS, and video image processing technologies, among other things. The Survey Vehicle is used for automatic collection of road inventory and pavement condition related data required for Road Asset Management, Pavement Maintenance Management System and Road Safety Audit Related Studies.
